## Worker survives excavator rollover

The purpose of this online incident investigation report is to identify the causes and contributing factors of this incident to help prevent similar incidents and to support preventive actions by industry and WorkSafeBC. This online version is not the official WorkSafeBC report. It has been edited to remove personal identifying information, some photographs, and details not essential to understanding the cause of the incident.

NI number: 2005138190147

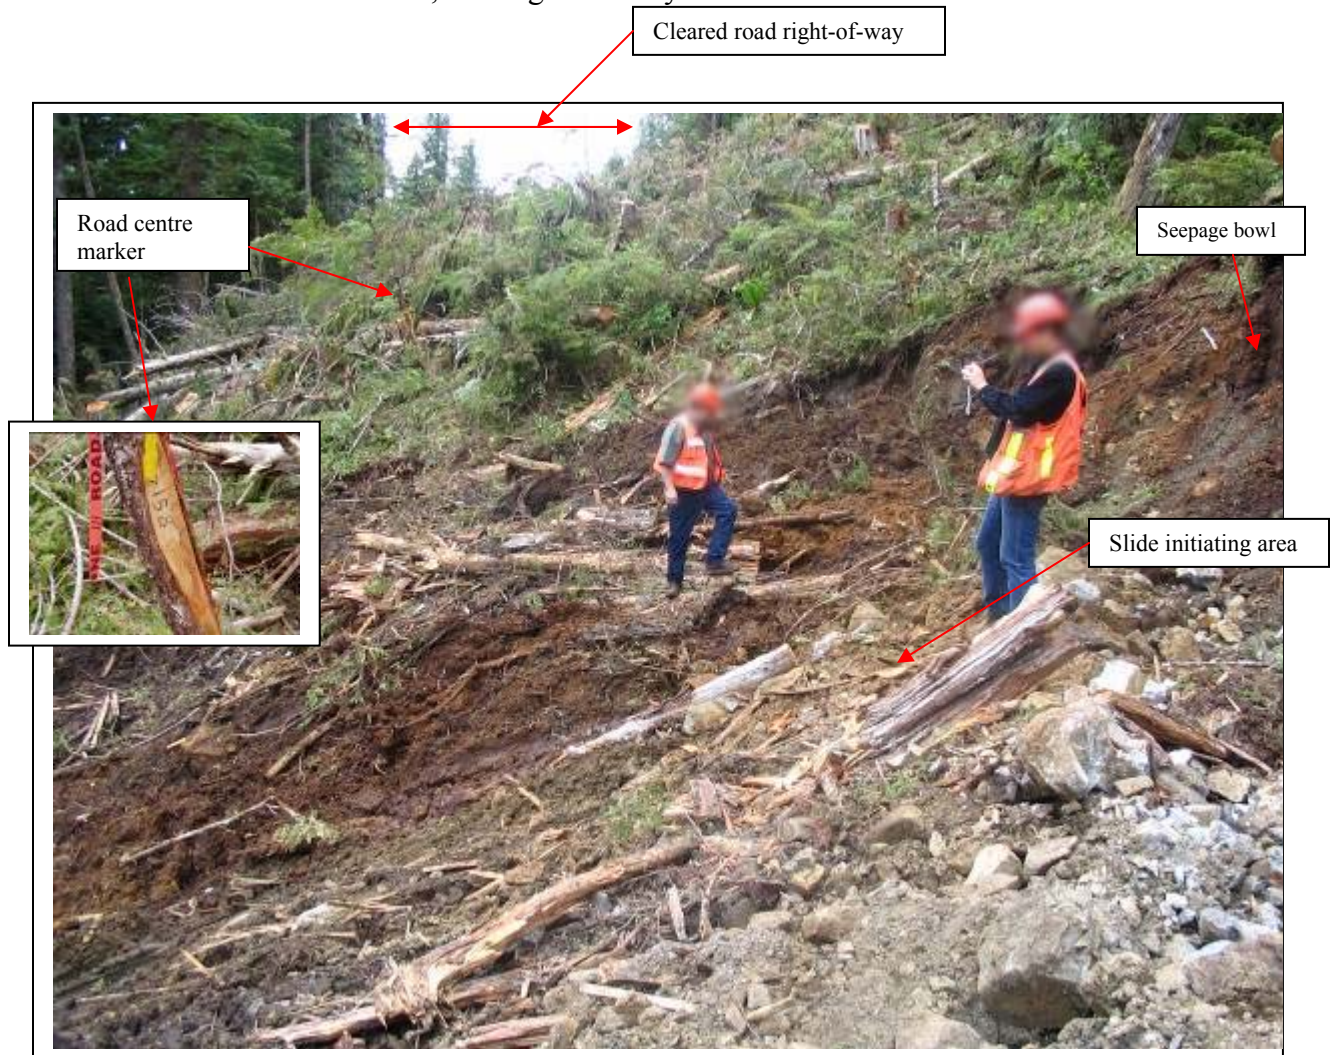
Photo 1: This photo taken after the incident shows the location of road centre marker.

The heading hoe operator who worked at the site the day before the incident stated that he was following the map and was aware of the seepage bowl in the area. He had noticed that the road centre marker was way off to the left, and had he followed the marker they would have ended up with a dip in the road. Furthermore, he could feel with the bucket that the ground was very soft, which he described as “black mud on slippery rock.” For these reasons he proceeded to cut into the hill and moved to the right. He knew that the area was unsafe, and on the day before the incident, he told the utility hoe operator that the area was bad and that he should stay into the hill and keep cutting.

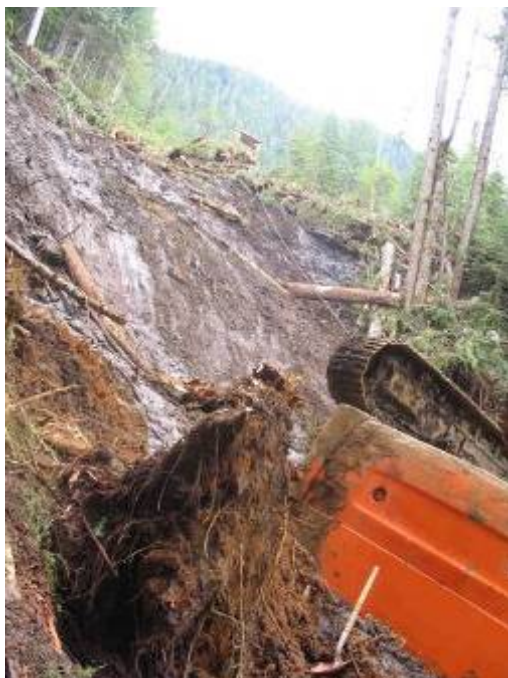
At approximately 1025 hours, the utility hoe operator travelled back and forth to pick up puncheon (small logs, branches, brush, etc.) to prepare a platform for the excavator. A few minutes later, as the utility hoe operator travelled back to get more puncheon, the excavator broke through the previously laid puncheon and slid down along a wet bank with a slope of approximately 40 percent. After sliding down the slope approximately 60 feet, the excavator toppled over an approximately 30-foot bedrock bluff, landing upside down on a lower bench approximately 150 feet below the road (see Photo 2).

Photo 2: The excavator slid down a steep muddy slope and over a bluff.

The road phase where the utility hoe operator was working had soft materials on top of slippery bedrock. Due to the seepage bowl, water was draining down the hill under the soft mud on top of the bedrock. This created an unsafe condition for the excavator, which weighs approximately 117,000 pounds. Furthermore, the crew conducted a heading shot in the area and the vibrations may have made the material unstable. The utility hoe operator was moving back and forth in the area and was setting up puncheon to build a new pad for the excavator. The back-and-forth movement of the excavator may also have made the materials unstable. Previous rainfall, although it did not exceed the rainfall shutdown limits, may have added to the saturation of the materials in the area that failed.

The site was reassessed by the geotechnician and instructions were provided to ensure that the work was carried out by experienced operators and that extra precaution would be taken through a 65-metre-long section where a similar seepage bowl existed.

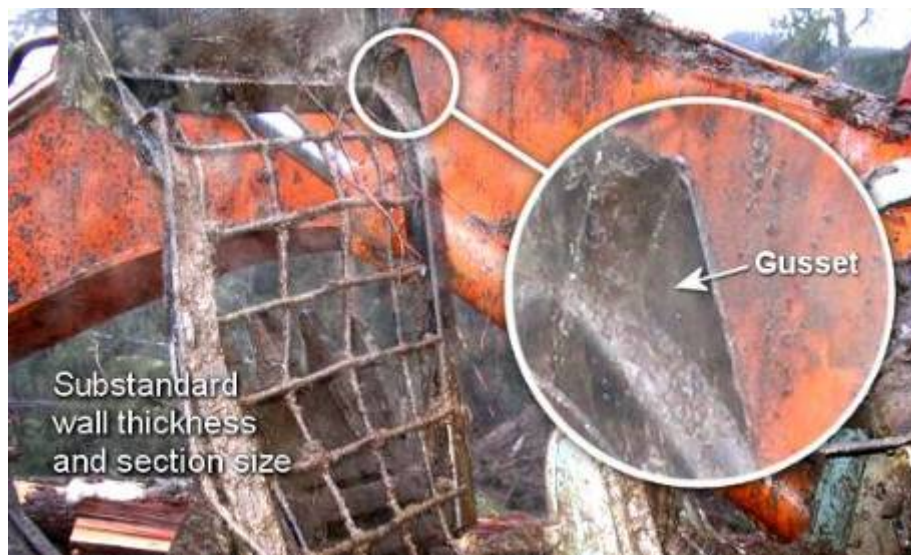
The WorkSafeBC engineer stated that for excavators in the 60,000–110,000 pound operating weight category, we would normally expect OPS with 4 x 4 x  $\frac{3}{8}$  inch square tubing with the joint between the legs and roof being gusseted. This would meet the requirement of the WCB Standard G602. However, the OPS on this machine was gusseted only at the joint between the roof and two front legs. Some of the welds on the OPS were inadequate in that the welds rather

than the parent material failed. The actual section size and wall thickness of the legs were less than what WorkSafeBC engineering has suggested for this type of application (see section 1.4.1).

The weld failures in the operator protective structure and limited deformation of the front legs suggest substandard construction as well as questionable design contributed to the failure. The WorkSafeBC engineer has suggested, and the lead investigator concurs, that the OPS on this machine did not meet the requirements in the following ways (see Photo 3):

- It lacked the gussets between all the legs and the roof section.
- The welds were inadequate in that the welds opened instead of the parent metal being torn.
- Unless certified as adequate, the supporting legs were not of sufficient size for an excavator of this capacity.

Photo 3: The operator protective structures did not meet requirements.

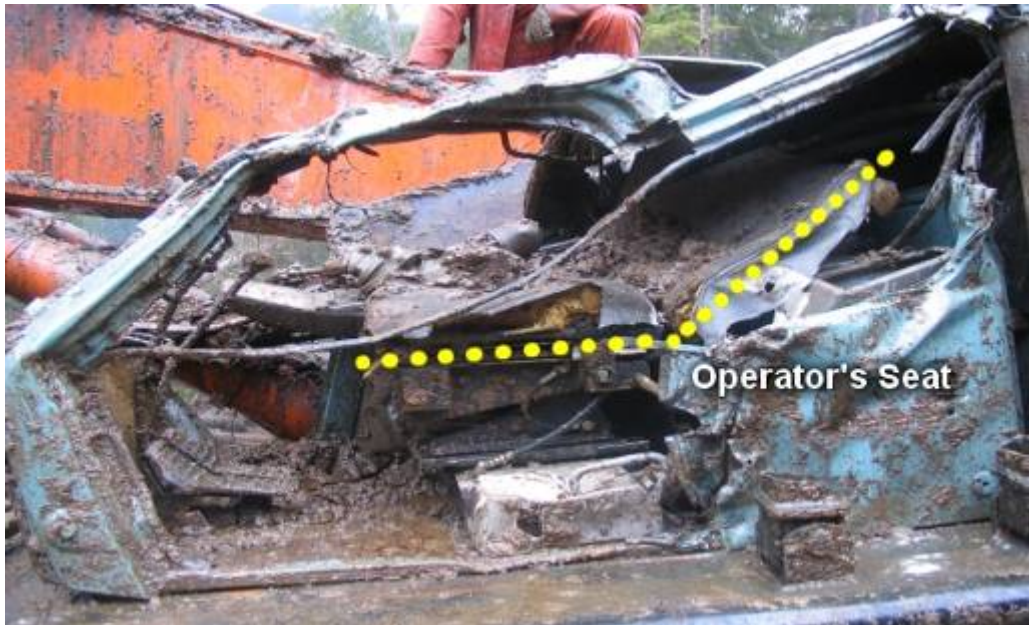
After reviewing all the available data with the WorkSafeBC engineer, we are unable to conclude that OPS fully meeting WorkSafeBC requirements would have stood up in this rollover. It can be concluded, however, that OPS fully meeting WorkSafeBC requirements would have absorbed considerably more energy before failing and would have been significantly more likely to have provided more survival space for the operator (see Photo 4).

Photo 4: The crushed cab.

The operator protective structures on this machine did not meet the minimum requirements and failed. OPS fully meeting WorkSafeBC requirements would have absorbed considerably more energy before failing and would have been significantly more likely to have provided more survival space for the operator.
