Worker pinned between forklift load and pile of veneer

Number: 2005116110061

Core activity: Veneer manufacture

Date of incident: March 2005

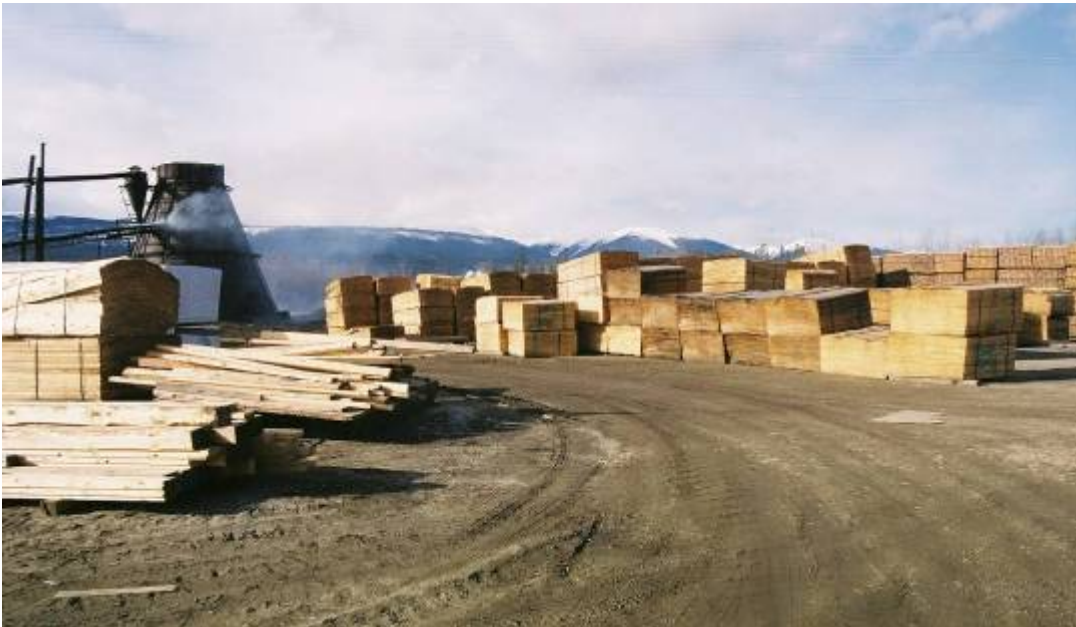
The company sells the veneer produced to plywood manufacturers in distant locations. During the winter preceding the fatal incident, there was a shortage of railway cars available to ship veneer from the plant. This resulted in a larger than normal inventory of veneer stored on the premises. The storage area near the planer was nearly full (see Photo 1).

Photo 1: Area of stored veneer near planer

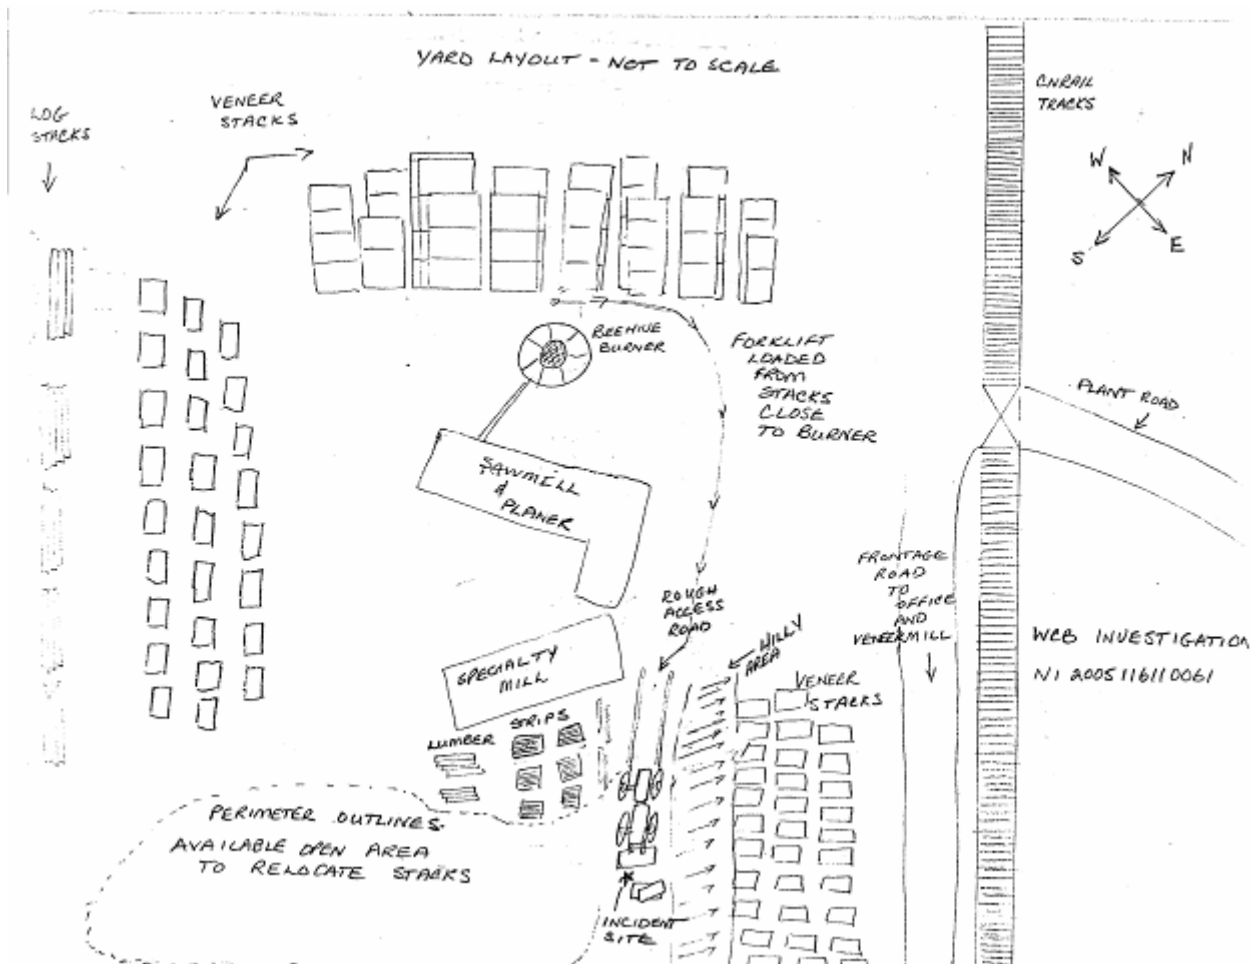
Diagram 1: Investigating officer's sketch of the yard and incident location, not to scale.

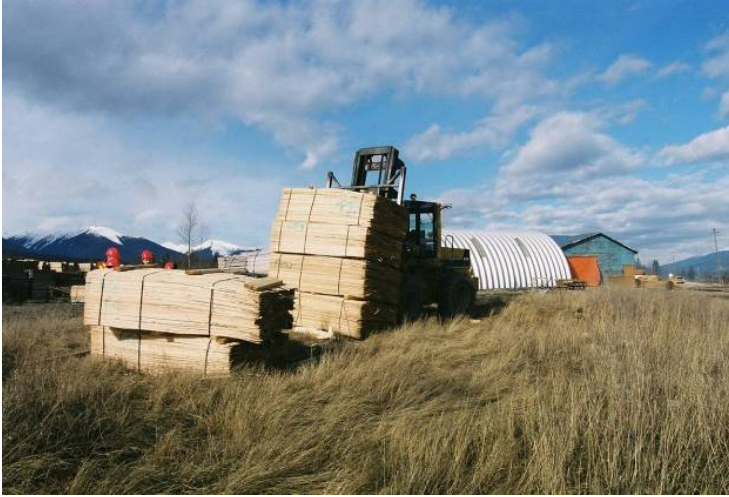
At the time of the incident, the forklift held four stacks of banded veneer. The banding was broken on the bottom stack. The individual stacks of veneer were about 30 inches in height. With the forks lowered to the ground after the incident, the four stacks of veneer were approximately 10 feet in height (see Photo 2).

Photo 2: Overview of incident scene

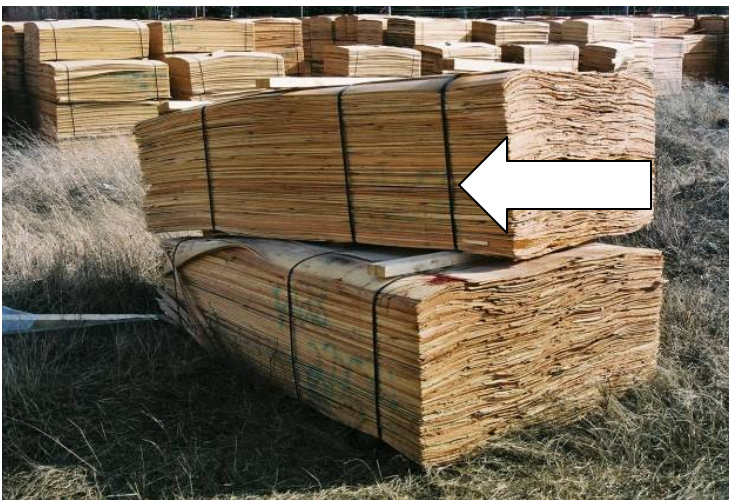
The forklift moved forward down the slope and pinned the spareman between the four stacks of veneer on the forks and the two stacks on the ground. He was facing the forklift.

There were two stacks of veneer on the ground in front of the forklift. After the incident, to assist in the rescue attempts, Forklift Operator 1 had moved the forklift a few feet back from where the spareman had been pinned, which is the position of the forklift shown in Photo 2. The top bundle of the two stacks of veneer was dislodged on one corner about 18 inches from alignment with the lower stack (see Photo 3). A small amount of blood was present on the lower stack. It was evident that the forklift had come forward at an oblique angle and contacted the upper bundle of the two stacks of veneer.

Photo 3: The arrow indicates the position of the spareman

- The employer instructed all operators to lower the forks to the ground and ensure the emergency brake is set when getting out of the machines.
- The employer instructed all operators to never enter the "crush zone" and always to work from the side when placing dunnage.
- The employer reviewed with the workforce the operator's right to refuse unsafe work and the responsibility to communicate hazards.
- The safe work procedures and job safety breakdown were redesigned.

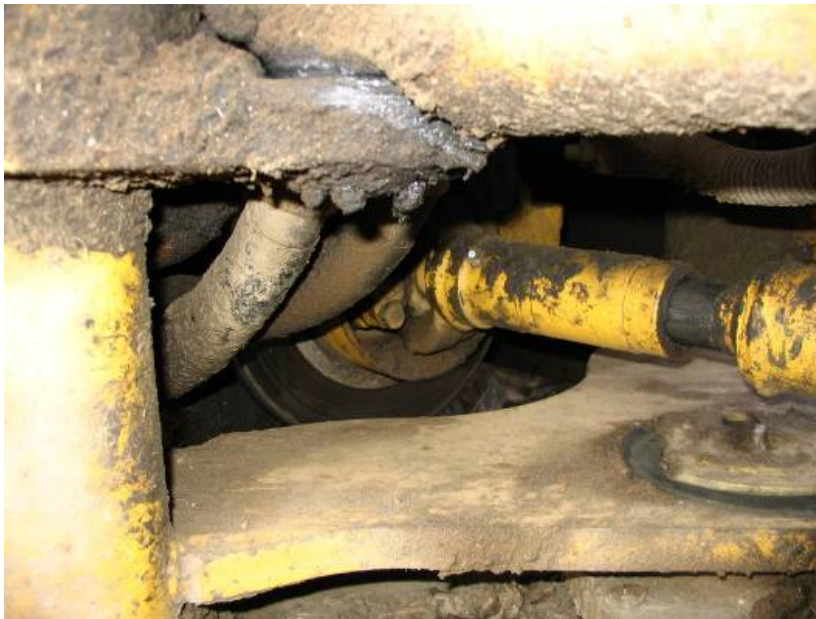
The machine has both a service braking system and an emergency brake. The emergency brake is the driveshaft disc brake type (see Photo 4). When applied through a control lever within the cab, a wire from the lever moves the parking brake calipers. The calipers move plates that hold the two disc brakes and cause both discs to enclose around the driveshaft at the transmission output coupling. This halts the energy transfer from the transmission to the driveshaft.

Photo 4: Transmission output coupling and driveshaft disc brake

This form of emergency brake system does not, by its design, disable wheel motion. The front axle of the four-wheel drive machine has a crown and pinion gear in mid-axle, and therefore does not have a locking gear differential function upon the wheels. This design allows free wheel motion of either wheel independent of the other wheel. For example, if one wheel has limited traction or no traction, the other wheel could still rotate.

The forklift involved in the incident had a functional emergency brake. Although the brake worked, it was evident that the brake linkage wire to the hand lever was in need of adjustment. The lever had to be pulled to the maximum upright position to engage the brake. When the emergency brake linkage wire tension is properly adjusted, the brake should engage when pulled upward a few inches from the disengaged position.

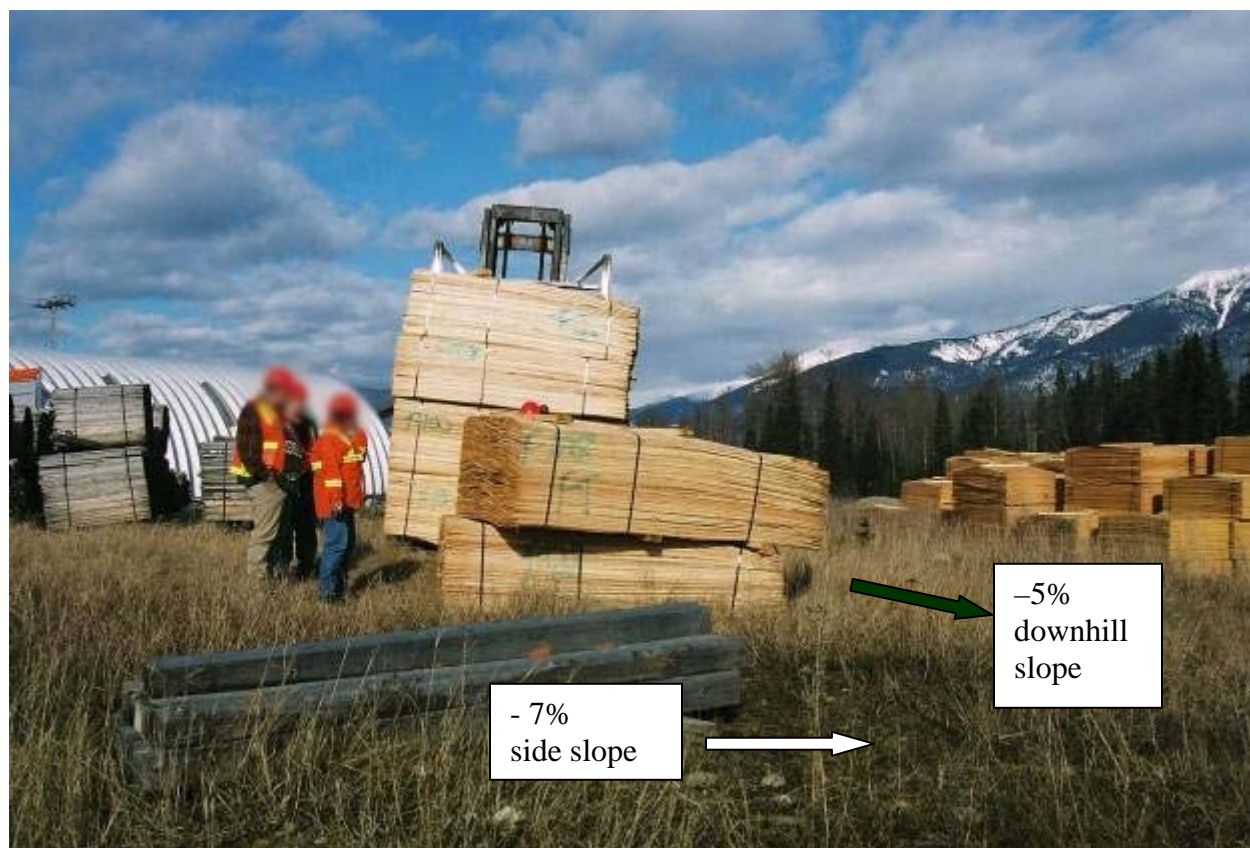
The ground in the area had a compound slope (both a downward slope and sideways slope). WorkSafeBC officers and mill personnel assessed the terrain slope together. The slope in the direction of the forklift's forward path of travel was found to be approximately -5% . Side slope of the ground was greater and was found to be -7% (see Photo 5).

Photo 5: Compound slope of the terrain where incident occurred. The black arrow shows a -5% downhill slope. The white arrow indicates a -7% side slope.
