Worker survives excavator rollover

Number: 2005138190147

Core activity: Logging road construction

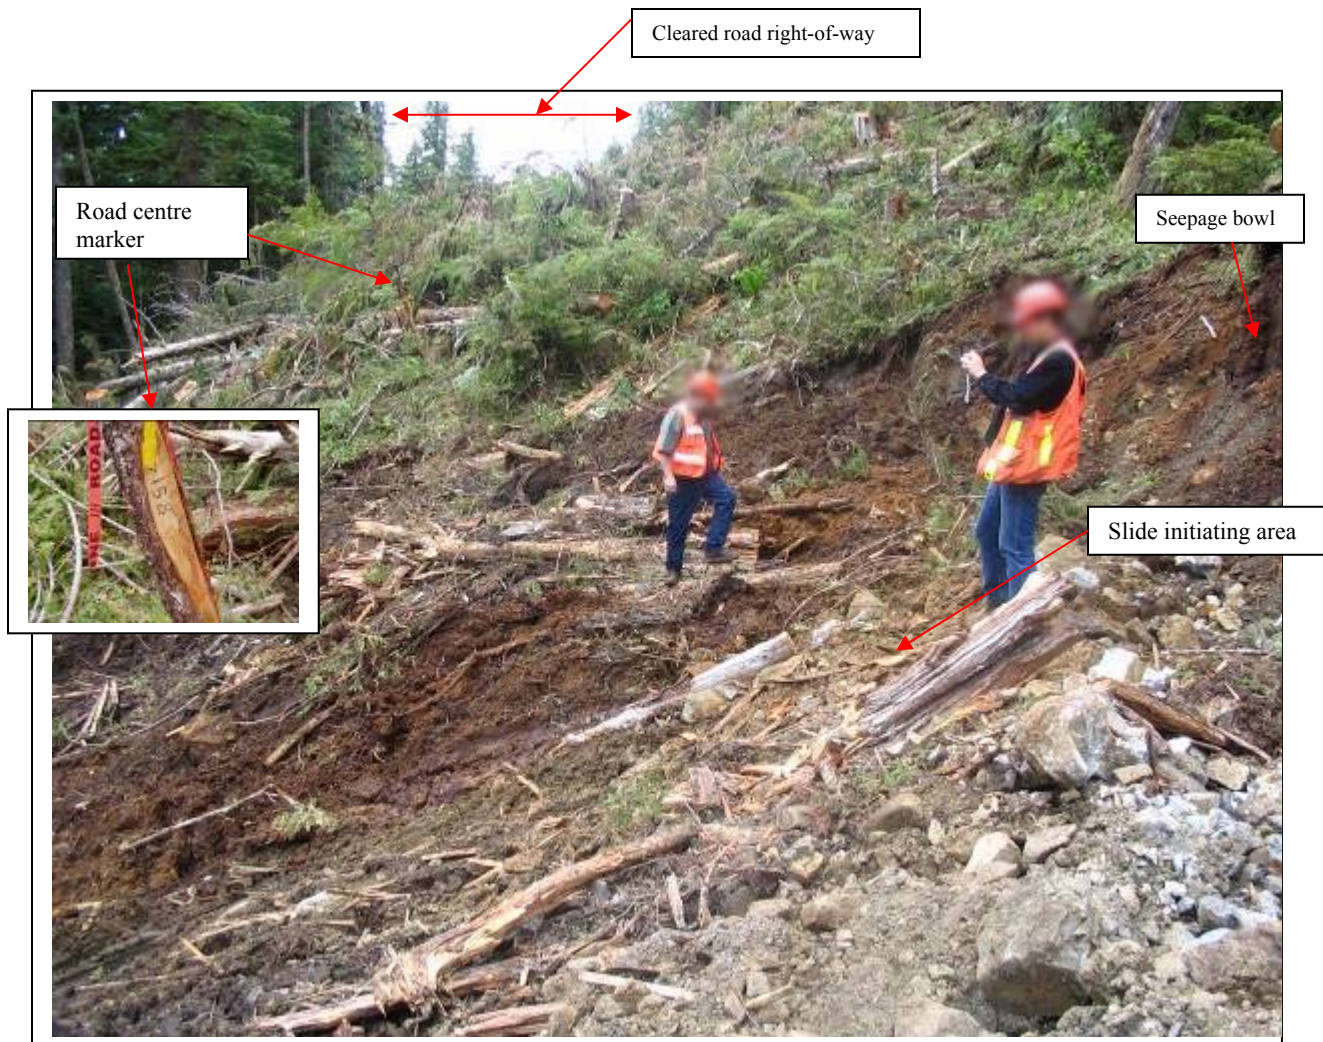
On the day before the incident, a [heading hoe operator](#) was working at the incident site pioneering the road. He was aware that the terrain stability report called for a $\frac{3}{4}$ bench endhaul. He noticed that the centre marker of the road was too far left down the slope (see Photo 1). He decided to move to the right and started cutting into the hill. He noticed that the ground was soft and slippery. He knew that there was a seepage bowl in the area, where the water was seeping through the ground and flowing on top of the solid rock. This resulted in a layer of water between the soil and solid rock, causing instability.

Photo 1: This photo taken after the incident shows the location of road centre marker.

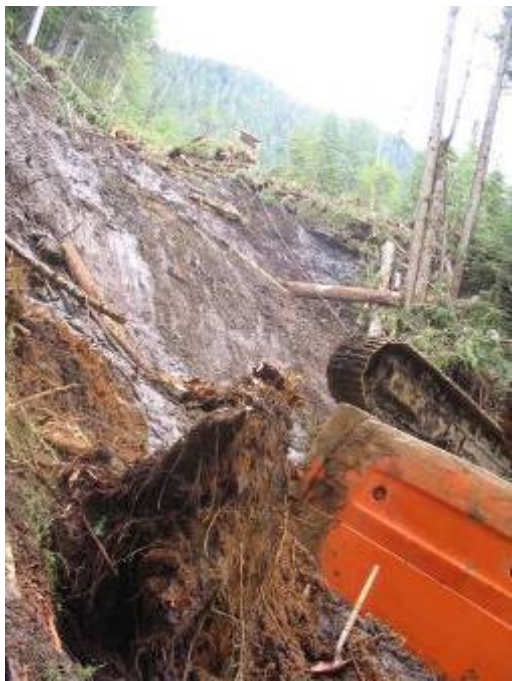
At approximately 1025 hours, the utility hoe operator travelled back and forth to pick up puncheon (small logs, branches, brush, etc.) to prepare a platform for the excavator. A few minutes later, as the utility hoe operator travelled back to get more puncheon, the excavator broke through the previously laid puncheon and slid down along a wet bank with a slope of approximately 40 percent. After sliding down the slope approximately 60 feet, the excavator toppled over an approximately 30-foot bedrock bluff, landing upside down on a lower bench approximately 150 feet below the road (see Photo 2).

Photo 2: The excavator slid down a steep muddy slope and over a bluff.

The road phase where the utility hoe operator was working had soft materials on top of slippery bedrock. Due to the seepage bowl, water was draining down the hill under the soft mud on top of the bedrock. This created an unsafe condition for the excavator, which weighs approximately 117,000 pounds. Furthermore, the crew conducted a heading shot in the area and the vibrations may have made the material unstable. The utility hoe operator was moving back and forth in the area and was setting up puncheon to build a new pad for the excavator. The back-and-forth movement of the excavator may also

have made the materials unstable. Previous rainfall, although it did not exceed the rainfall shutdown limits, may have added to the saturation of the materials in the area that failed.

The site was reassessed by the geotechnician and instructions were provided to ensure that the work was carried out by experienced operators and that extra precaution would be taken through a 65-metre-long section where a similar seepage bowl existed.

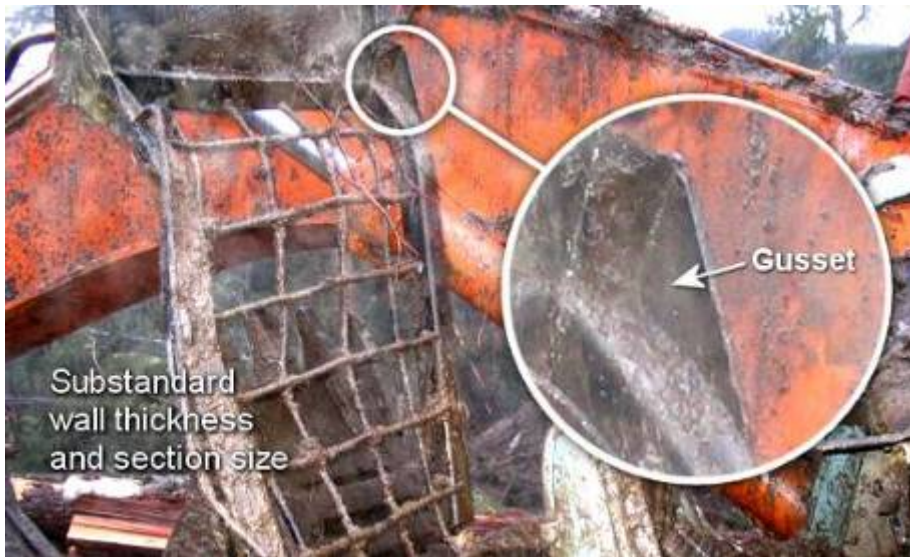
The FOPS roof and front supporting legs were still attached to the machine. The weld connection between the roof and front posts held. Parent metal tore and there was post deformation. The 2 rear left side legs had torn primarily in the welds at the roof connection. Approximately half of the welds failed in both of these connections. The rear right leg also tore close to the attachment to the roof. Here the failure was primarily [of] parent metal. There was no evidence of gussets for the rear connections. The 3 rear posts were missing as they had been removed in the extraction of the worker. The weld area showed the 2 left side rear posts were 3½ x 3½ x ¼ wall square tubing.

The front window guard, consisting of 3½ x 3½ x ¼ square tubing post frame and ¾ inch round stock welded to the inside of the tubing, was bent towards the boom and somewhat to the rear. The knee welds in the posts approximately ⅓ of the way from the bottom opened from the rear. There was no tearing of parent metal in these welds, suggesting lack of penetration. The posts were only slightly distorted.

The weld failures in the operator protective structure and limited deformation of the front legs suggest substandard construction as well as questionable design contributed to the failure. The WorkSafeBC engineer has suggested, and the lead investigator concurs, that the OPS on this machine did not meet the requirements in the following ways (see Photo 3):

- It lacked the gussets between all the legs and the roof section.
- The welds were inadequate in that the welds opened instead of the parent metal being torn.
- Unless certified as adequate, the supporting legs were not of sufficient size for an excavator of this capacity.

Photo 3: The operator protective structures did not meet requirements.

- Ensure that its workers are made aware of all known and reasonably foreseeable health or safety hazards to which they are likely to be exposed by their work.
- Ensure that all road construction work is conducted in accordance with the written instructions of a professional engineer when required.
- Provide its workers with adequate instruction training and supervision necessary to ensure health and safety of those workers in carrying out their work duties.
- Ensure that mobile equipment operator protective structures (OPS) meet the minimum requirements of the Occupational Health and Safety Regulation.

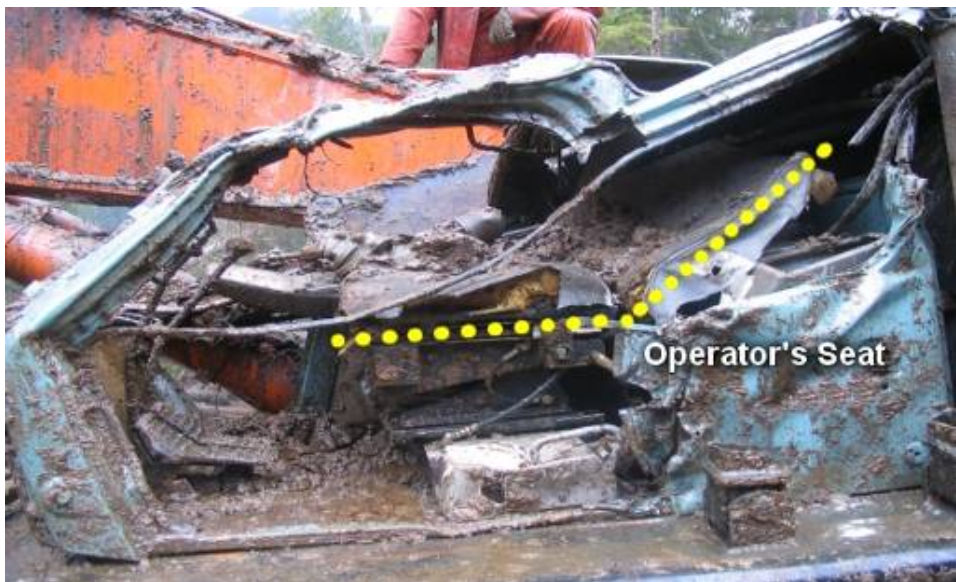
After reviewing all the available data with the WorkSafeBC engineer, we are unable to conclude that OPS fully meeting WorkSafeBC requirements would have stood up in this rollover. It can be concluded, however, that OPS fully meeting WorkSafeBC requirements would have absorbed considerably more energy before failing and would have been significantly more likely to have provided more survival space for the operator (see Photo 4).

Photo 4: The crushed cab.

The operator protective structures on this machine did not meet the minimum requirements and failed. OPS fully meeting WorkSafeBC requirements would have absorbed considerably more energy before failing and would have been significantly more likely to have provided more survival space for the operator.
