Framer falls through stair openings

Purpose of this report

Number: 2006155070109

Outcome: Fatal

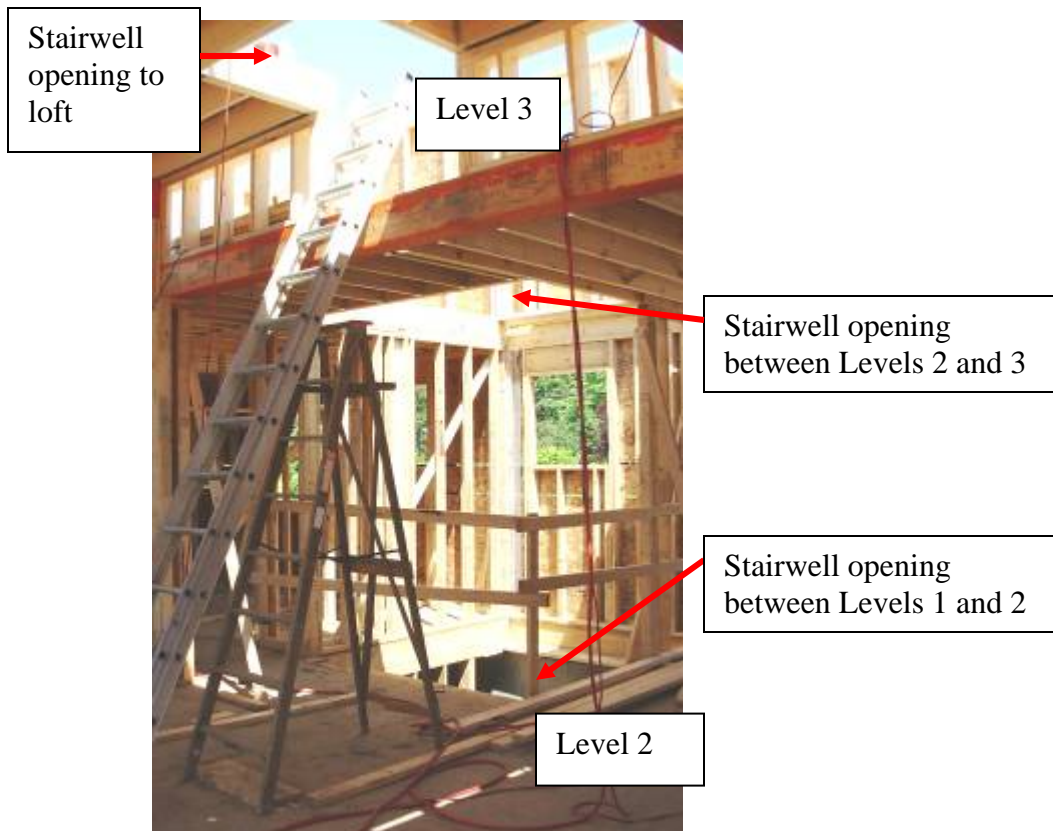
Figure 1: The vertically aligned stairwell openings going from Levels 1 to Level 3. The stepladder was used for access and egress between Levels 2 and 3. The guardrails and extension ladder were put in place after the incident.

The framer was assigned to help the foreman build the walls. The framer and the foreman accessed Level 3 by using a stepladder positioned on Level 2 under the stairwell opening (see Figure 1). The top plate of this stepladder was approximately 2 feet under the Level 3 loft opening.

This employer was also found in contravention of the Occupational Health and Safety Regulation, [section 13.5\(c\)](#), which states that a ladder must have sufficient length to project approximately 1 metre (3 feet) above the upper landing to which it provides access. At the time of the incident, the upper level was accessed by a stepladder that was approximately 2 feet short of the floor it was intended to access.

This employer was also found in contravention of the Occupational Health and Safety Regulation, [section 20.5\(5\)](#), which states that a stairway comprised of at least framing, treads, and a handrail must be provided to each floor level before construction of the next floor or deck surface is undertaken, and the treads on the stairway must not create a tripping or slipping hazard. The employer was ordered to ensure that stairways meeting these requirements are provided to each floor level before construction of the next floor or deck surface is undertaken.

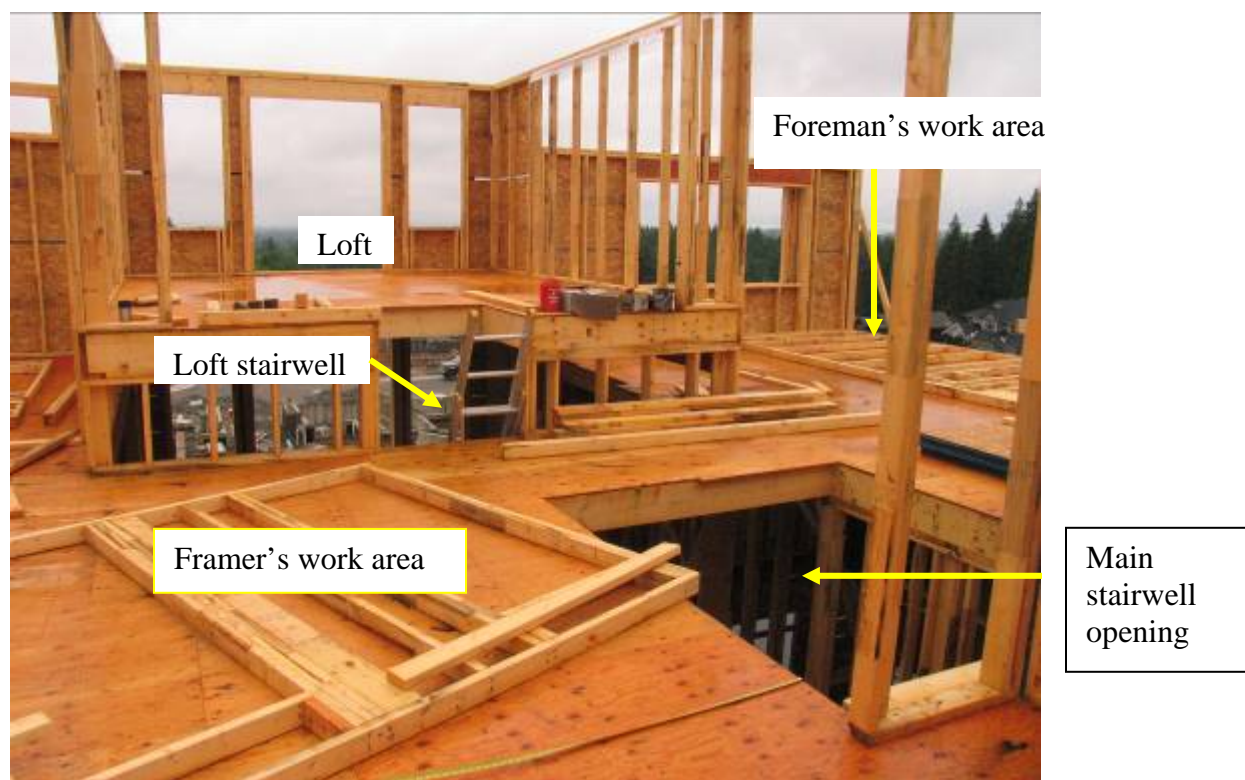
The framer was framing an internal wall, one corner of which slightly overlapped the Level 3 main stairwell opening (see Figure 2). The framer had vapour barrier laid out, ready to nail to the top plate of the wall, and he was using a pneumatic nailer. The foreman was framing the west wall. He was also using a pneumatic nailer.

Figure 2: Layout of Level 3, including the approximate positions of the framer and the foreman at the time of the incident. The main stairwell is vertically aligned with the stairwell on Level 2. There are several places where a worker could fall from a height: the main stairwell, loft stairwell, loft leading edge, and the west leading edge (on the right). At the time of the incident, a stepladder rather than the extension ladder was used for access.

None of the stairwell openings at the incident site were covered, nor were railings placed around any of them. The leading edge of the west wall did not have railings along it, nor did the leading edge of the loft, nor the loft stairwell (see Figure 2). No fall prevention systems or personal fall protection systems were being used on Level 3 at the time of the incident. The framer and foreman were working 18.5 feet above the basement level.

This section summarizes three orders issued to Jewell Ventures after the incident. This employer was found in contravention of the Occupational Health and Safety Regulation, [section 11.2\(1\)\(b\)](#), which states that an employer must ensure that a fall protection system is used when work is being done at a place from which a fall of 3 metres (10 feet) or more may occur. The employer was ordered to ensure floor openings are securely covered or guarded by fixed or movable guardrails.

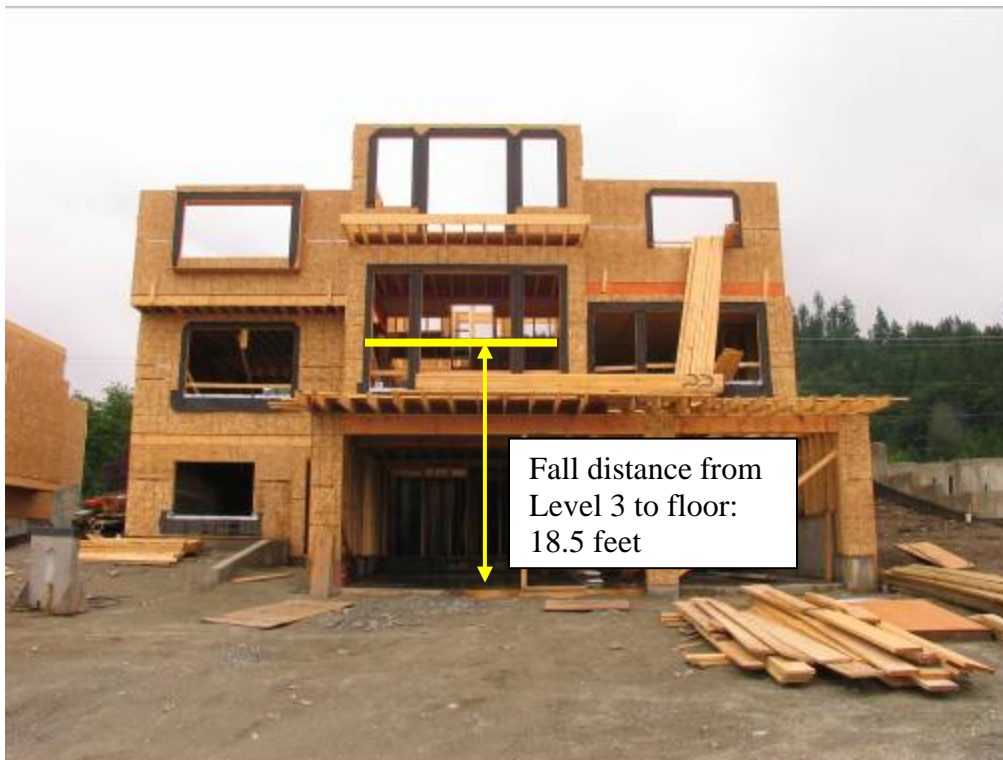
At approximately 09:00, the foreman was looking down at his tape measure when he heard a noise. When he looked up, the framer was no longer on Level 3. The framer had fallen through the two vertically aligned open stairwells, a distance of 18.5 feet (5.6 metres), and landed on the concrete floor of the basement (see Figure 3). First aid was performed, and the framer was taken to hospital, where he later died of his injuries.

Figure 3: Distance from Level 3 to concrete floor.

The framer fell—likely by a slip, a trip, or an inadvertent step—over the unguarded edge of an open stairwell. He fell 18.5 feet to the basement level. There were no fall protection measures in place.
