Three farm workers killed in 15-passenger van rollover

Purpose of this report

Number: 2007137101997

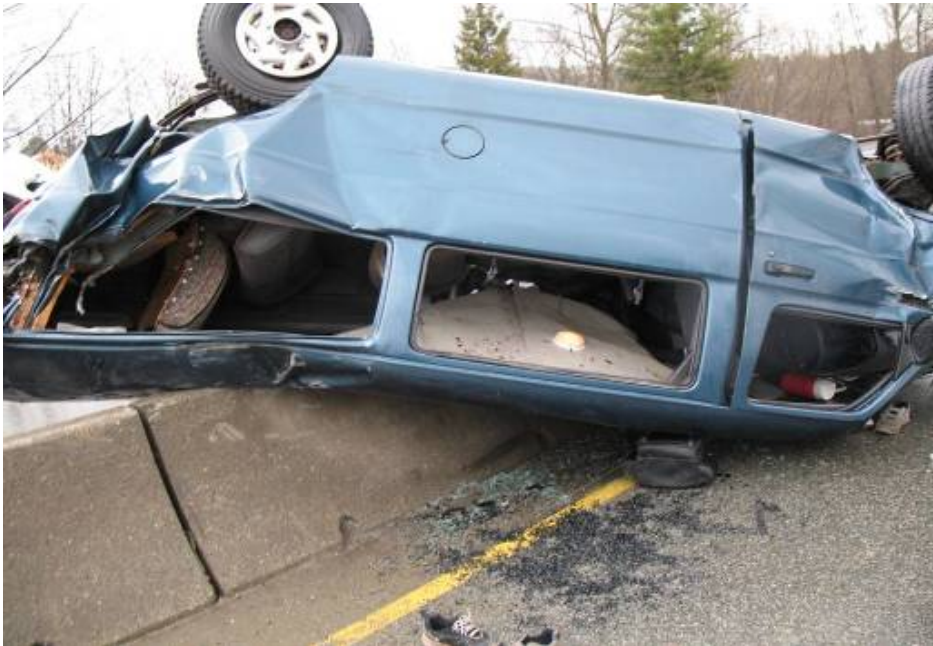
On March 7, 2007, at about 06:20, a 15-passenger van owned by RHA Enterprises Ltd. carrying 16 farm workers plus the driver was travelling east on Highway 1 to Rainbow Greenhouses Inc. in Chilliwack, B.C. The vehicle collided with two transport trucks, rolled, and landed on its roof on the highway median (see Figure 1). Three workers were killed and 14 others injured.

Figure 1: The van after the incident.

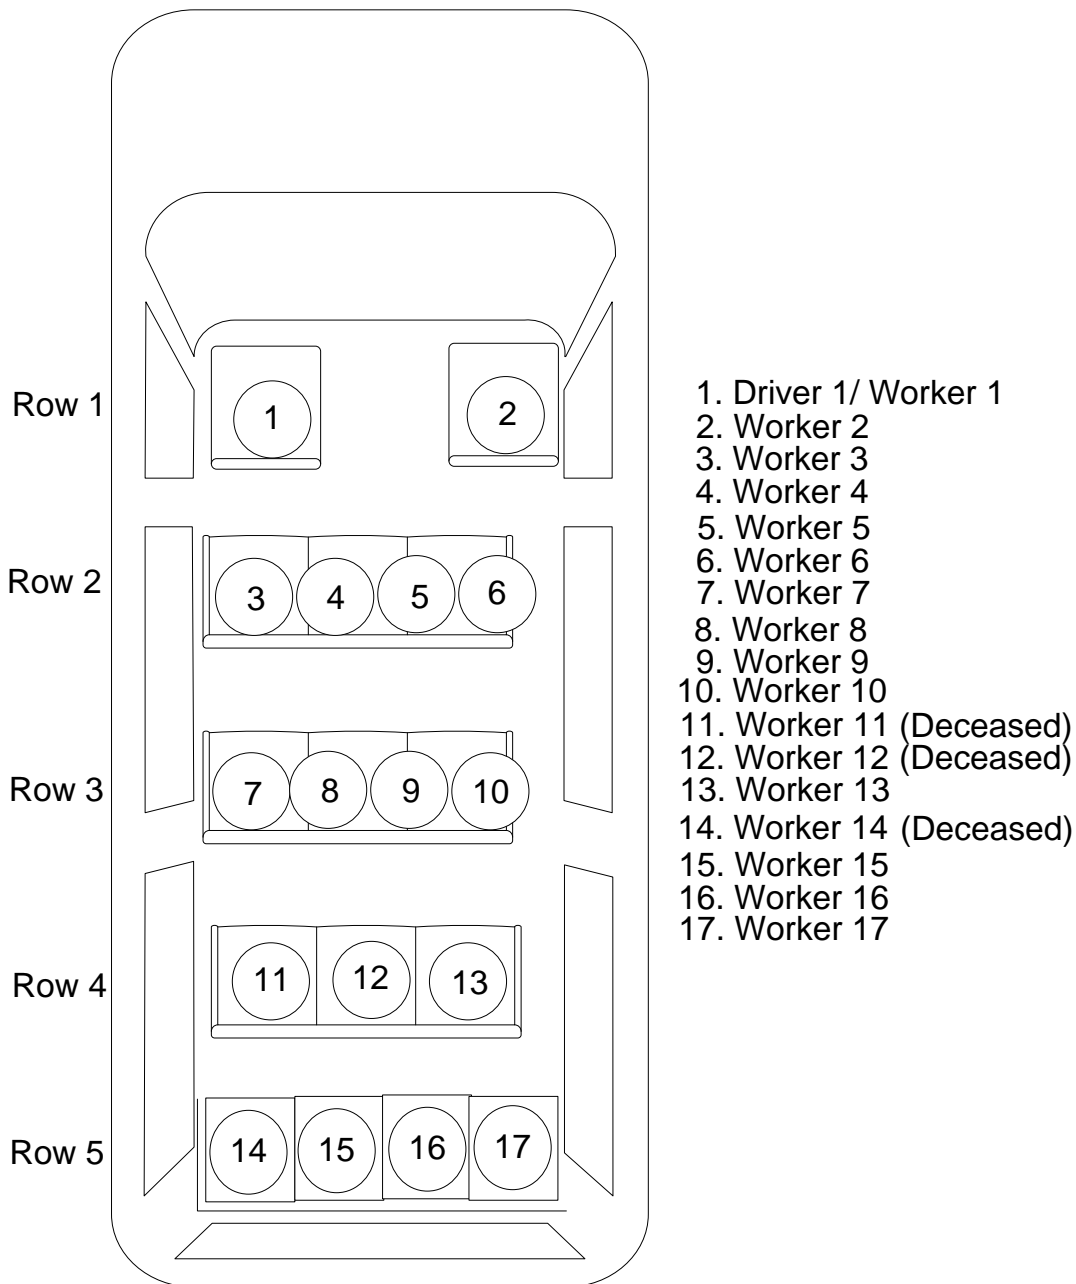
Figure 2: Seating locations of workers on the day of the incident.

The vehicle was designed for 15 occupants in five rows. At the time of the incident, rows 2 and 3 each carried four passengers, one more than they were designed for (see Figure 2 on page 4).

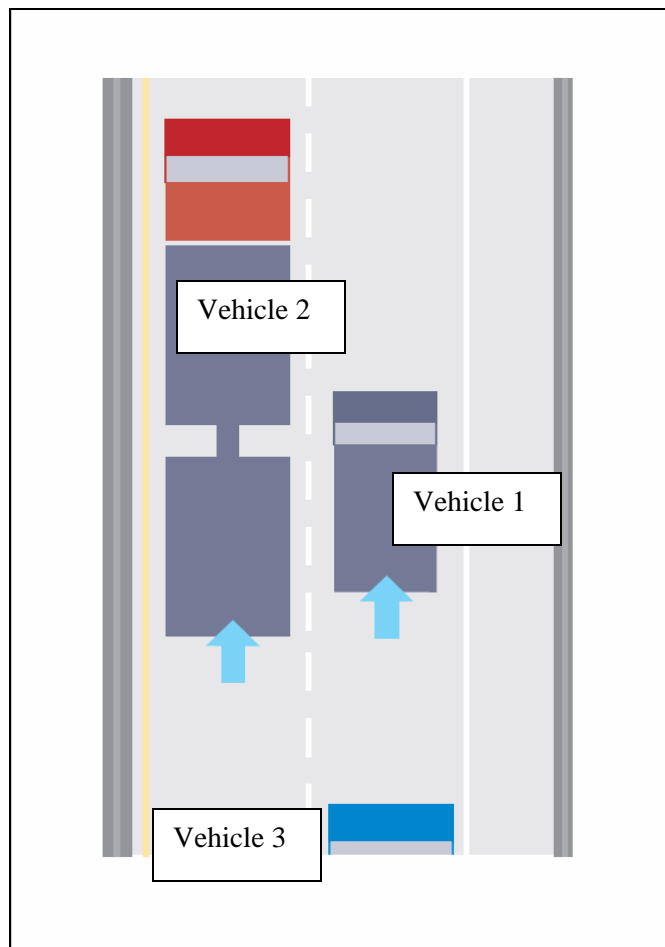
At about 06:20, Vehicle 1 was travelling east in the curb lane of Highway 1 at approximately 90 km/h beside Vehicle 2, a dump truck and trailer owned by Mid-Valley Sand & Gravel. Vehicle 2 was also travelling east at approximately 90 km/h (see Figure 3) in the centre lane beside Vehicle 1.

Figure 3: Position of the three vehicles before the incident.

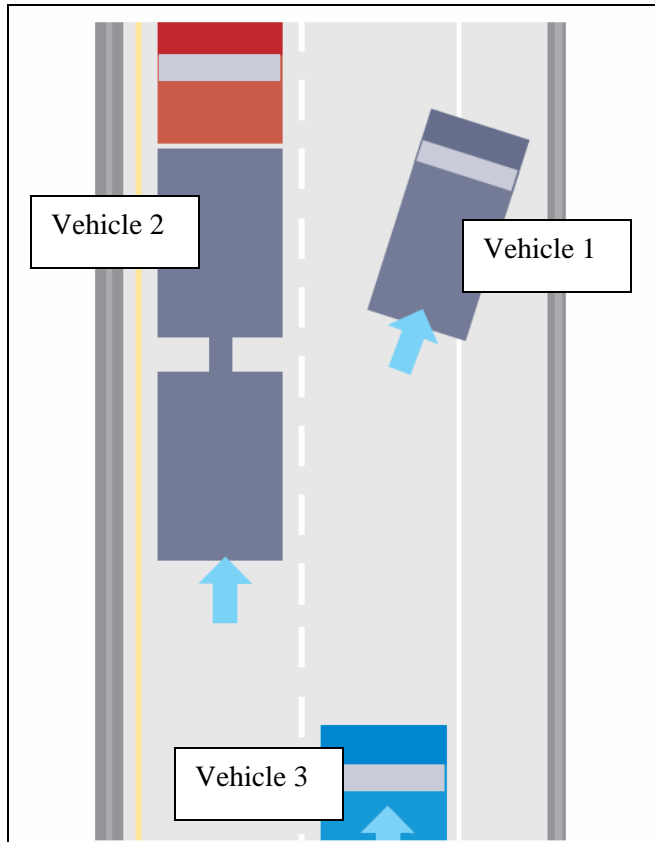
Shortly after, as Vehicle 1 approached a concrete overpass, it moved on to the road shoulder heading towards the curb and guardrails (see Figure 4). Driver 1/Worker 1 attempted to correct the van's path by steering Vehicle 1 to the left. Vehicle 1 then struck the front right end of the trailer of Vehicle 2 (see Figure 5). Vehicle 1 then slowed down and moved back into the curb lane.

Figure 4: Vehicle 1 moved to the right.

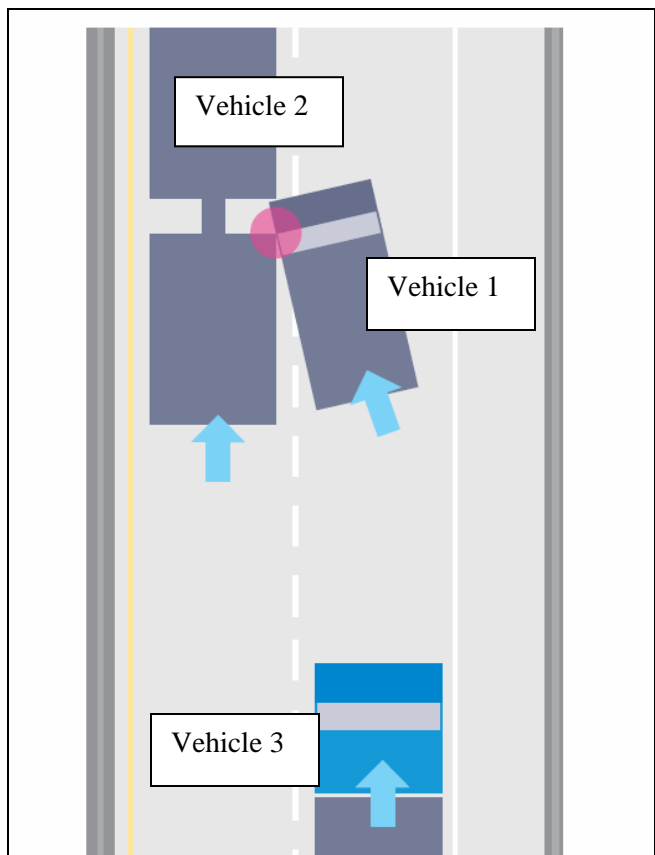
Figure 5: Vehicle 1 steered too far to the left and hit the trailer of Vehicle 2.

In the incident Vehicle 1 moved to the right onto the paved shoulder as it approached the concrete overpass. It appears that Driver 1/Worker 1 over-corrected the steering, turning too far to her left; as a result, Vehicle 1 approached the centre lane. Vehicle 1 struck the right front corner of the trailer of Vehicle 2. The collision caused Vehicle 1 to move back into the curb lane. Vehicle 1 decelerated rapidly. Vehicle 3 was behind and could not slow down, striking the left rear of Vehicle 1. Vehicle 1 may have spun around before eventually stopping upside down on the concrete median.

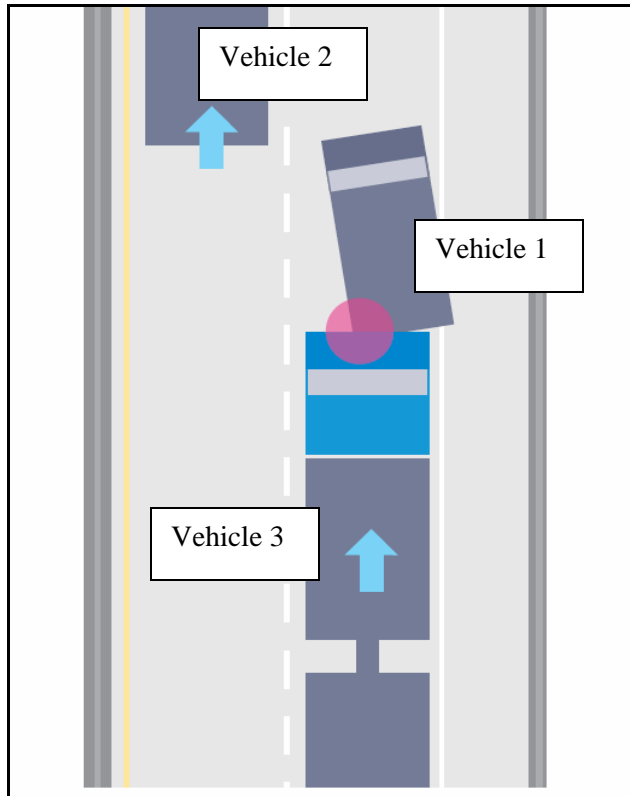
As Vehicle 1 slowed down, it was struck from behind by Vehicle 3 (see Figure 6). Vehicle 1 rolled and landed upside down on the centre median (see Figure 7). First responders from the Abbotsford fire department reported that when they arrived at the scene they found Vehicle 1 upside down on the highway median. Occupants were either inside the van or hanging out through the windows and doors.

Figure 6: Vehicle 1 slowed down and was struck from behind by Vehicle 3.

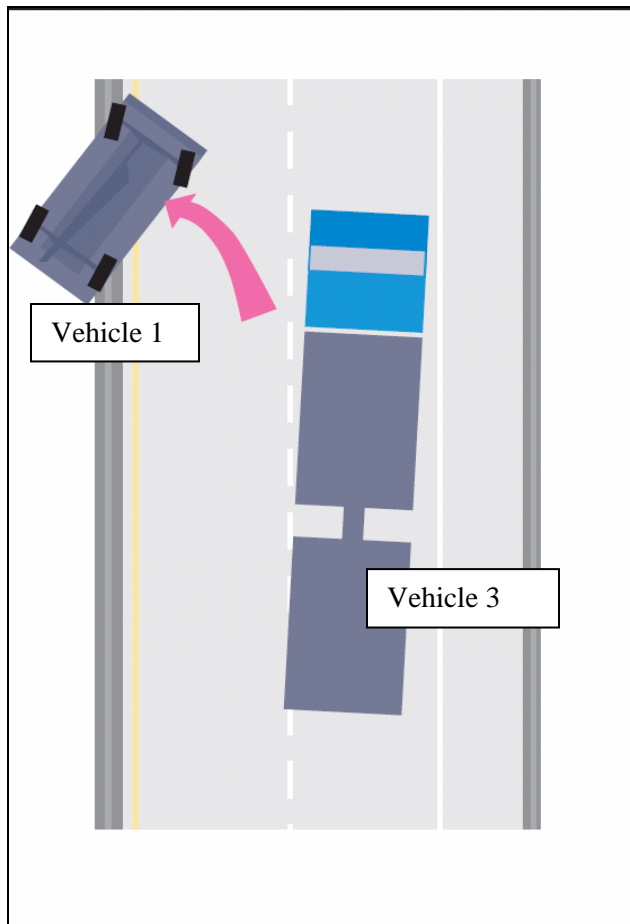
Figure 7: Vehicle 1 rolled and landed upside down on the median.

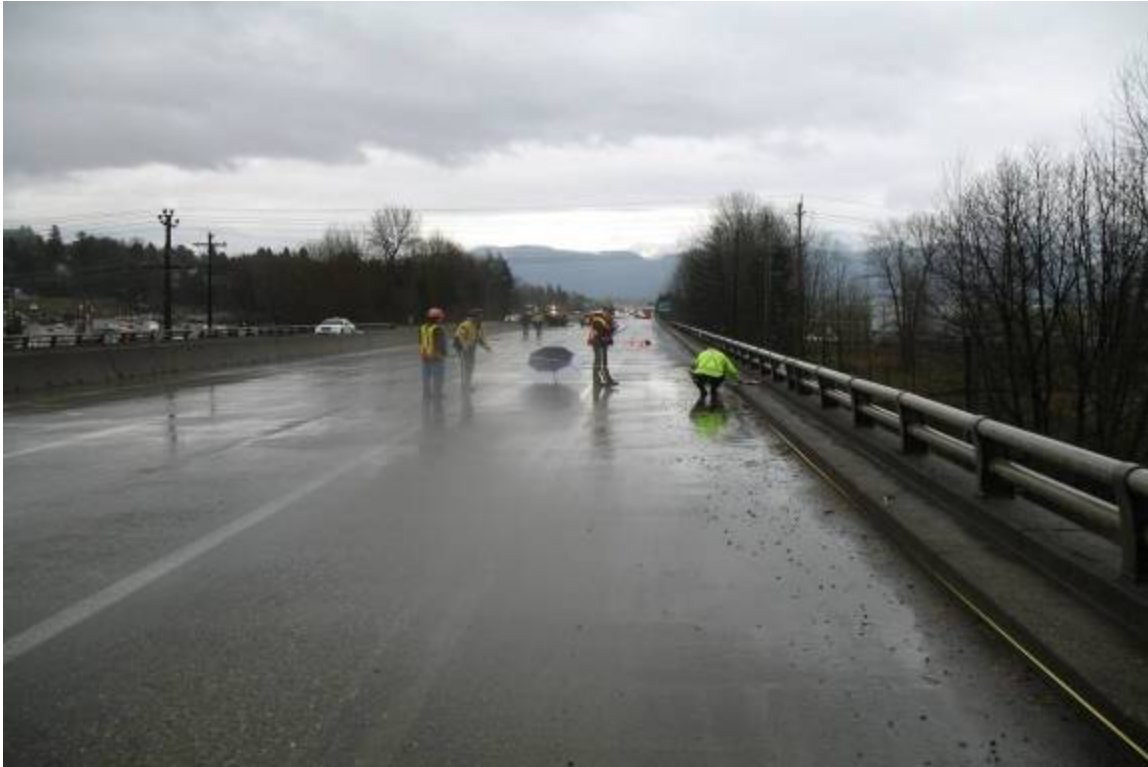
The incident occurred on Highway 1 eastbound on a concrete overpass just before the Highway 11 exit. The road has a downward slope of 6 percent just before the overpass. The road shoulder widens to about 10 feet over the concrete overpass (see Figure 8).

It was raining heavily. Visibility was poor. The roads were wet. Rainwater was flowing down the slope at the entrance to the concrete overpass.

Figure 8: The concrete overpass, showing the road shoulder.

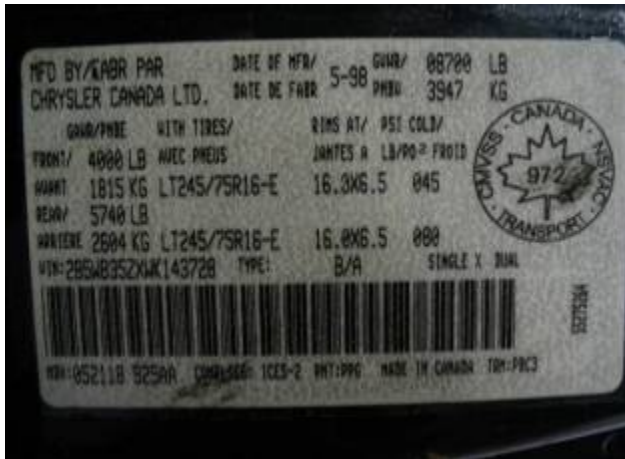
Vehicle 1 was a 15-passenger Dodge Ram 350 van manufactured in May 1998. The odometer read 377,437 kilometres. The vehicle was equipped with a factory compliance plate (see Figure 9). RHA Enterprises purchased Vehicle 1 in 2004.

Figure 9: Compliance plate.

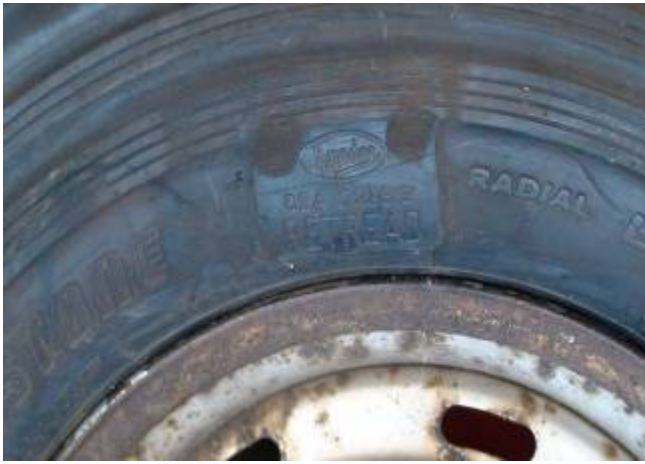
The left rear tire was an LT245/75R16 LRE Bandag, Retread, with Bridgestone M773 SWP II, M+S radial casing. Figure 10 shows the retread stamp, although information is missing. The tread depth was 15 millimetres. The tire bead had been displaced from the rim in the incident. The manufacturer’s compliance plate recommends the rear tires be inflated to 80 psi, which is also the maximum pressure indicated on the tire side wall. The tire had inner liner damage consistent with having been run under-inflated or flat before the incident. As part of the investigation, the left rear tire was remounted on the rim and inflated to 80 psi. The tire lost 24 psi of pressure over four weeks. Further investigation showed there was a small leak at the valve stem.

Figure 10: Retread stamp on left rear tire.

Examination of the left rear tire shows that this tire too was likely under-inflated before the incident. The bead had dislodged from the rim in the incident. If the tire had been inflated to 80 psi, the bead would not have dislodged without evidence of major trauma (for example, a blowout, marks of major impact, or other apparent physical damage). This evidence was not found. The rim damage on a small section on one edge is inconsistent with running flat for any significant distance. This suggests the tire pressure was low but the tire was not flat before the incident. Markings inside the tire and rubber powder inside the assembly are evidence of the tire having been run under-inflated at some time. The tire on its rim assembly dropped from 80 psi to 56 psi over four weeks. In summary, the left tire's deflation without apparent signs of trauma, the evidence of having at some time been run under-inflated, the tire on its rim assembly losing air, and no evidence that tire pressure is routinely checked all make it probable that the left rear tire was low before the incident.

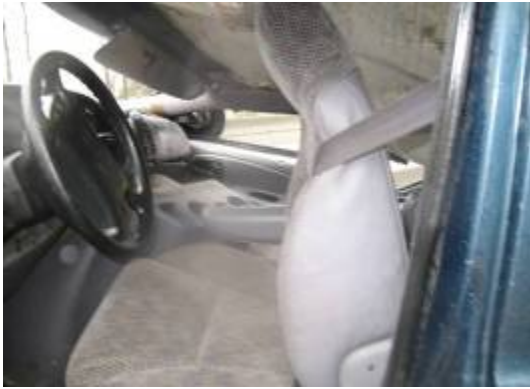
Figure 11: Driver's seat.

Row 1 seats two people. The driver's bucket seat is located at the front on the left, and the front passenger bucket seat is located on the right. Both of these seats were bolted to the floor with the manufacturer's original attachment points. The driver's seat did not show any damage other than the backrest, which was tilted forward (see Figure 11). The passenger seat backrest had tilted backwards (see Figure 12). Both these seats had their original upholstery.

The driver's seat and the front passenger seat were each equipped with a combination shoulder/lap seat belt. At the time of the inspection, the seat belts were fastened. There was no noticeable damage to either seat belt, which appeared to be the manufacturer's original belts. Worker 2 in the front passenger seat was wearing her seat belt at the time of the incident. Driver 1/Worker 1 was also wearing her seat belt.

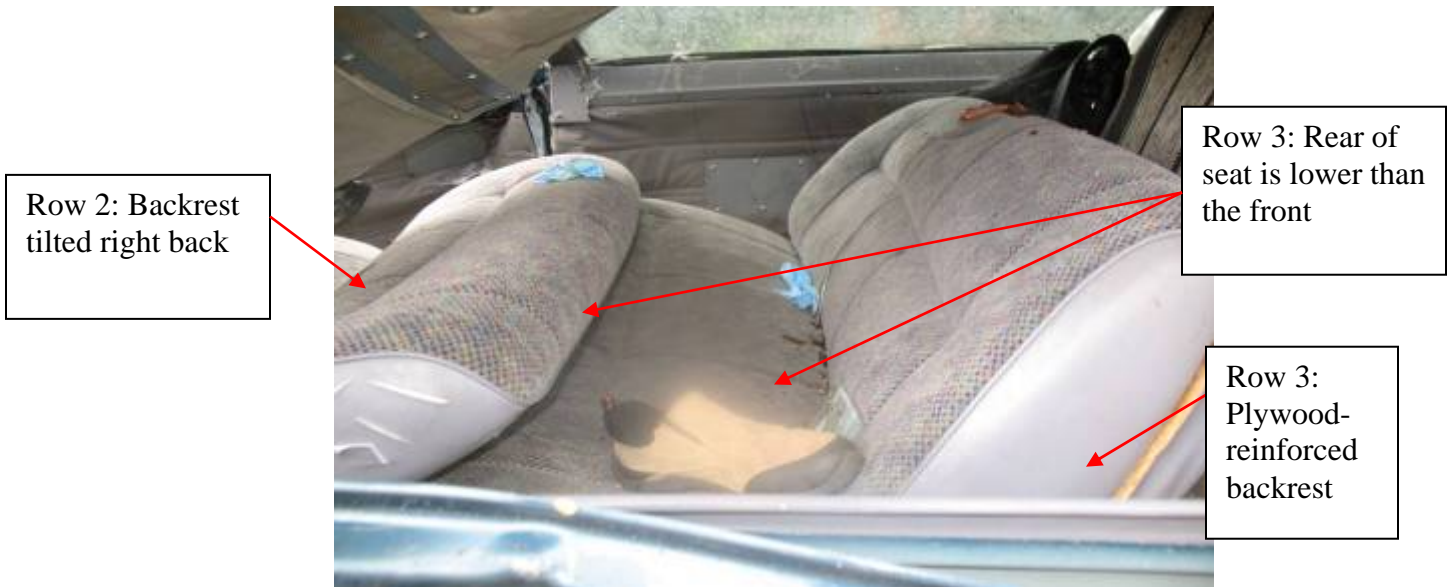
Figure 13: Rows 2 and 3.

Row 2 was equipped with a removable seat for three passengers, but it carried four passengers at the time of the incident. The seat was secured to the floor with the manufacturer's original equipment. This seat had its original upholstery (see Figure 13). Seat belt anchor points were located on the left side of the seat above the window and under the seat on the seat's lower rear horizontal cross-member. There were no seat belts fitted on this seat. There was no armrest on the right side of the seat, although marks on the side of the seat suggest that the vehicle had been manufactured with an armrest. The backrest had tilted backward.

Row 3 was equipped with a removable seat for three passengers, but it carried four passengers at the time of the incident. The seat was secured to the floor with the manufacturer's original equipment. It had its original upholstery (see Figure 13). Seat belt anchor points were located on the left side of the seat above the window and under the seat on the seat's lower rear horizontal cross-member. There were no seat belts fitted on this seat. There was no armrest on the right side of the seat, although marks on the side of the seat suggest that the vehicle had been manufactured with an armrest. The backrest of this seat had been reinforced with 5/16-inch plywood. The rear of the seat was lower than the front (see Figure 13).

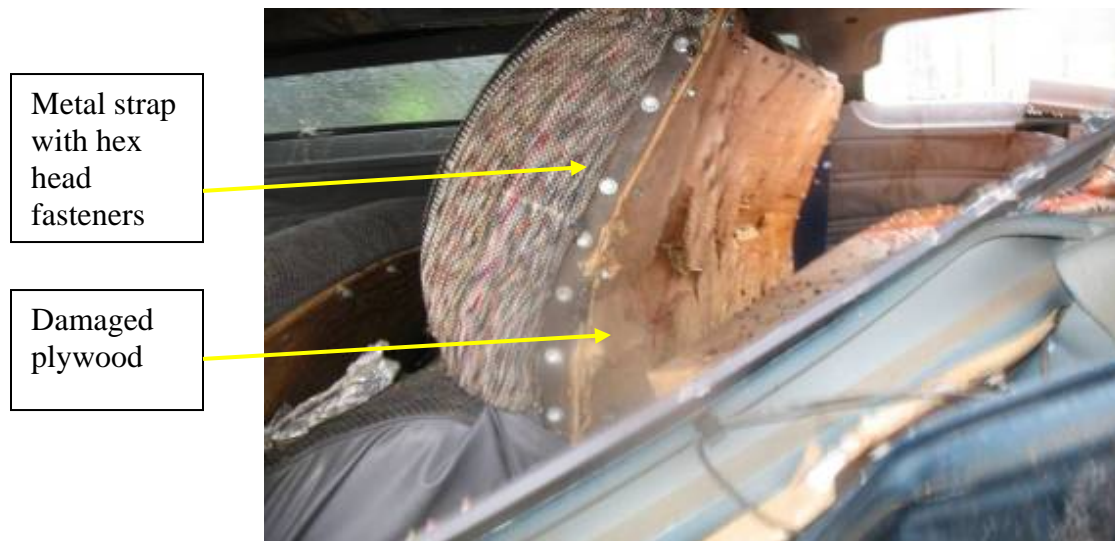
Seat belt anchor points were located on the left side of the seat above the window and under the seat on the seat's lower rear horizontal cross-member. There were no seat belts fitted on this seat. There was no armrest on the right side of the seat, although marks on the side of the seat suggest that the vehicle had been manufactured with an armrest. The back of the backrest of this seat had been reinforced with 5/16-inch plywood.

The backrest was reinforced with flat steel straps attached with seven hex head fasteners to the left and right sides of the backrest. In the incident, the backrest had been tilted back so that it was almost level with the top of the bottom seat cushion. The support under the seat cushion had been pushed up and to the right. The plywood on the back of the seat backrest showed damage consistent with the occupants of row 5 striking the plywood with excessive force during the incident (see Figure 14).

Figure 14: Row 4, showing damaged plywood.

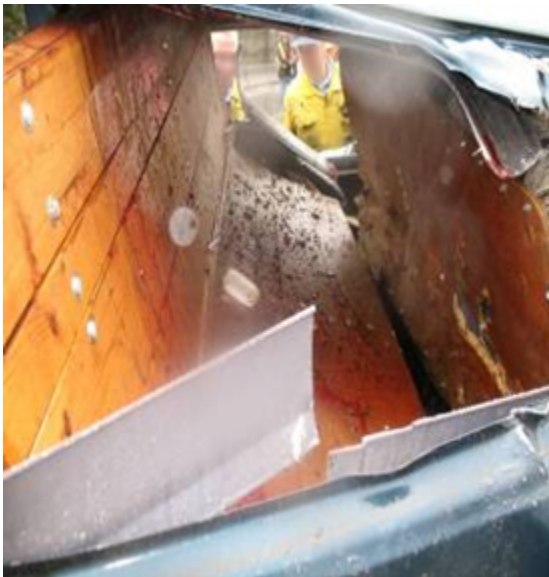
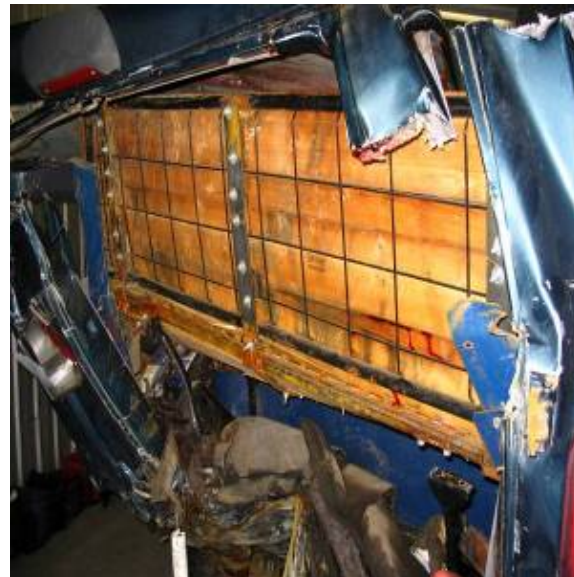
Row 5 was equipped with a bench seat for four passengers. The seat was bolted to the floor with the manufacturer's original attachments. The seat frame was the manufacturer's original, but the padding and upholstery had been removed. The frame had been modified with steel and lumber. Three steel straps (¼ x 2 inches) had been welded to the seat frame and bottom rests. Holes had been drilled through the steel straps so that lumber could be fastened to the straps. Pieces of lumber—2 x 3 inches and 2 x 6 inches and each 68 inches long—had been secured to the steel straps using carriage bolts, flat washers, lock washers, and nuts. The nuts had been tightened from underneath and behind the seat. The lumber was used to provide a seating surface and a backrest for passengers (see Figures 15 and 16).

Several finishing nails protruded from the seating area lumber, suggesting that some form of padding had at one time been secured for passengers' comfort. Seat belt anchor points were located on the left side of the seat above the window, on the right side in the corner, and under the seat on the vehicle floor. There were no seat belts on this seat.

The absence of the seat belts is discussed in the analysis in section 2.6. The other modifications to the Row 5 seat bench were not found to be a contributing cause of the incident or a factor in the severity of the injuries sustained.

Figure 15: Front of row 5.

Figure 16: Rear of row 5.

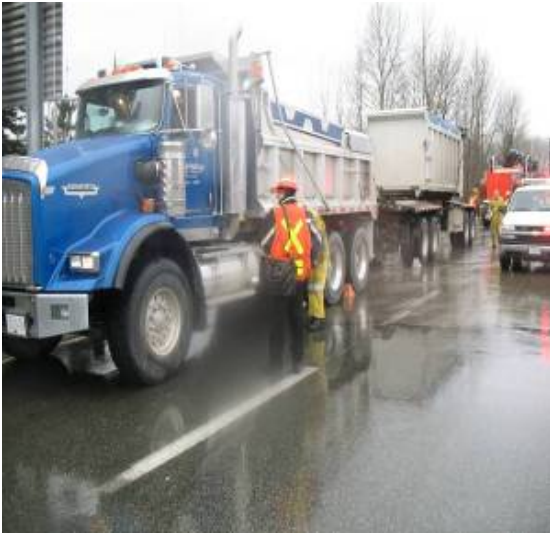
Figure 17: Vehicle 2 truck-trailer combination.

Vehicle 2 was a dump truck and trailer combination belonging to Mid-Valley Sand & Gravel. The dump truck was a 2007 Kenworth, and the trailer was a 2003 K-line. The dump truck and trailer of Vehicle 2 were empty. The collision did not damage the dump truck. The trailer had some damage to the front right corner (see Figures 17 and 18).

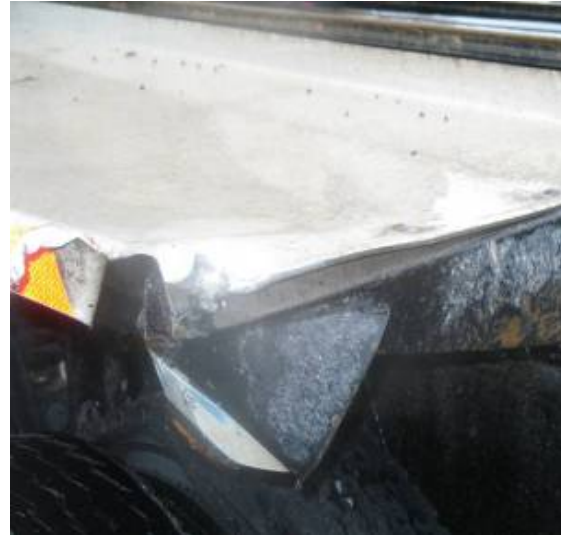
Figure 18: Damage to front of trailer.

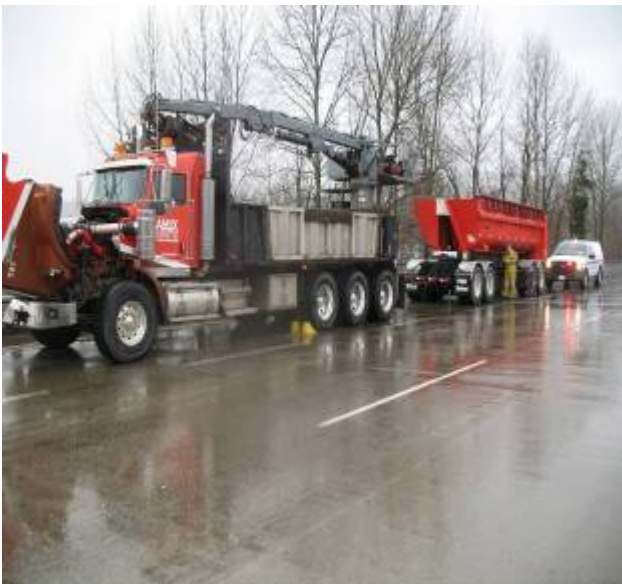
Figure 19: Vehicle 3 combination.

Vehicle 3 belonging to Amix Salvage & Sales was a 2006 Kenworth flat bed with a box and self loader towing a 2007 Midland box trailer (see Figure 19). The box on the flatbed and the trailer were empty. The front end of the truck was damaged when it hit Vehicle 1 (see Figure 20). The trailer unit was not damaged.

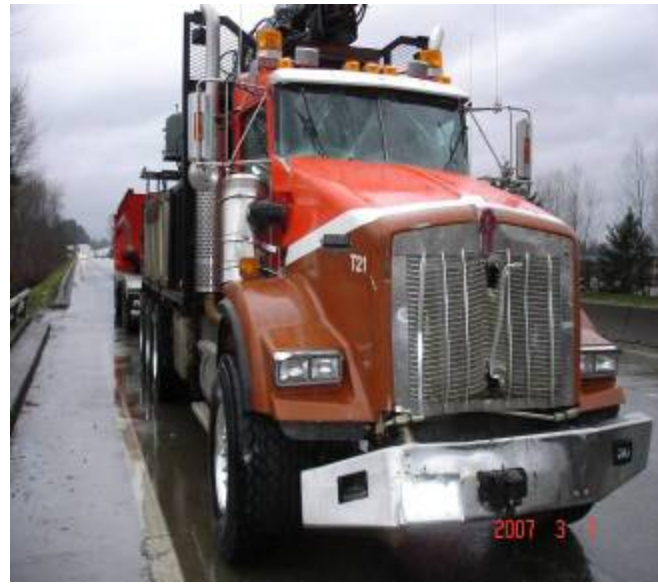
Figure 20: Damaged front end of Vehicle 3.
