Worker falls through roof insulation to concrete floor

Purpose of this report

Number: 2007157520114

Core activity: Applying roofing materials to building under construction

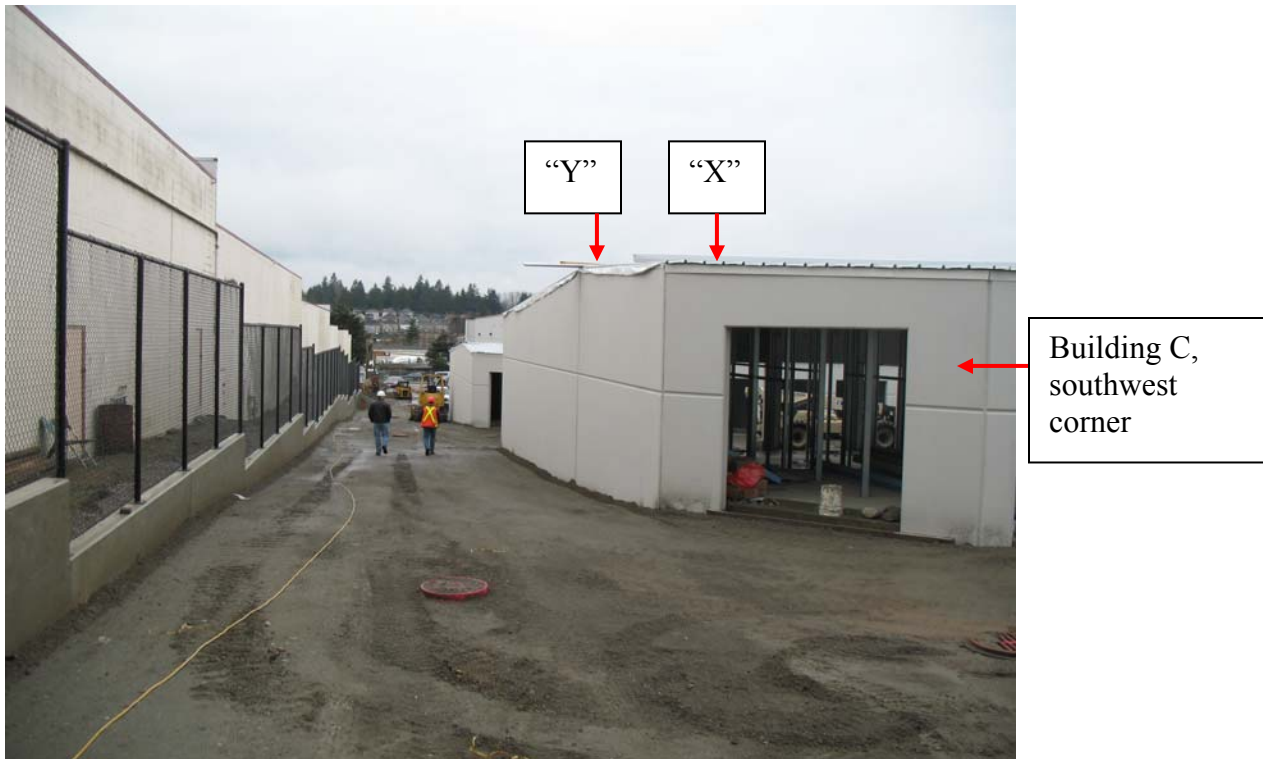
Charge Hand 1 and the three workers started with the roofing preparation by connecting the power cords, setting up the ladder, and moving supplies and insulation. They accessed the roof by climbing a ladder on the lower side of Building C. The height from roof to grade varied between 11 feet (3.4 metres) and 17 feet (5.2 metres) as there was a lower floor level dug out under part of the building (see Figure 1).

Figure 1: View of Building C, looking north. From the roof at “X” the distance to grade is 11 feet. From the roof at “Y” it is 17 feet to grade.

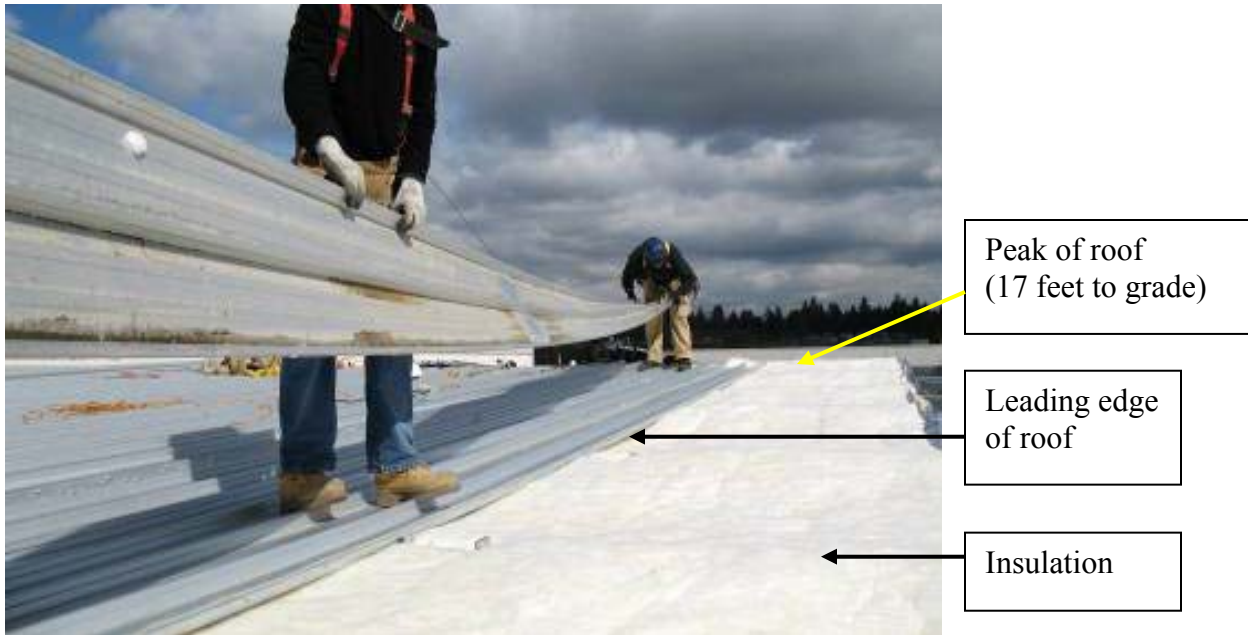
In the afternoon, Charge Hand 1 and the three workers carried a roof panel to the edge of the previously laid panel and moved the new one into position, using the same procedure that they had repeated all morning. Charge Hand 1 and the three workers were positioned at equal distances along the 41-foot-long roof panel, with Charge Hand 1 at the lower end of the roof (north edge) and Worker 1 at the slightly higher end near the peak of the roof (see Figure 2).

Figure 2: After the incident, workers (wearing fall protection) show how the roof panels were held as they were laid down.

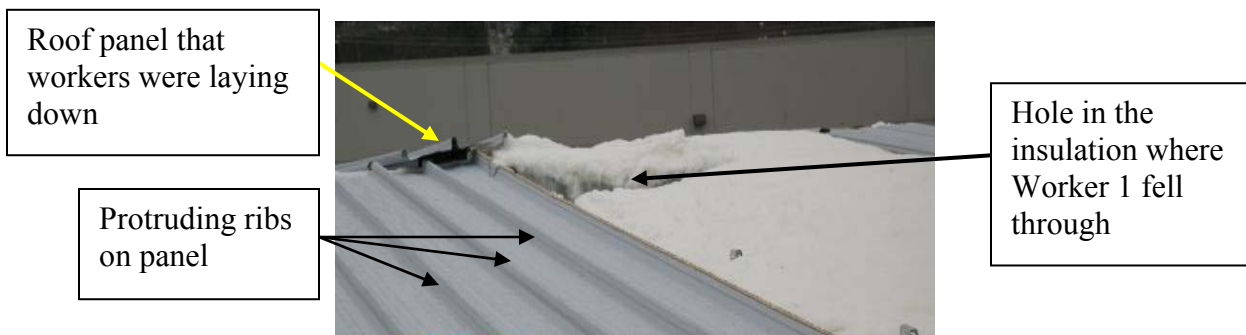
There was nothing unusual while this panel was being placed into position. This same routine had been followed repeatedly since they started work that morning. Charge Hand 1 heard a crashing noise, turned around, and saw Workers 2 and 3 looking at a hole through the insulation near where Worker 1 had been working (see Figure 3).

Figure 3: The site of the incident, showing the blanket insulation and the roof panels with protruding ribs.

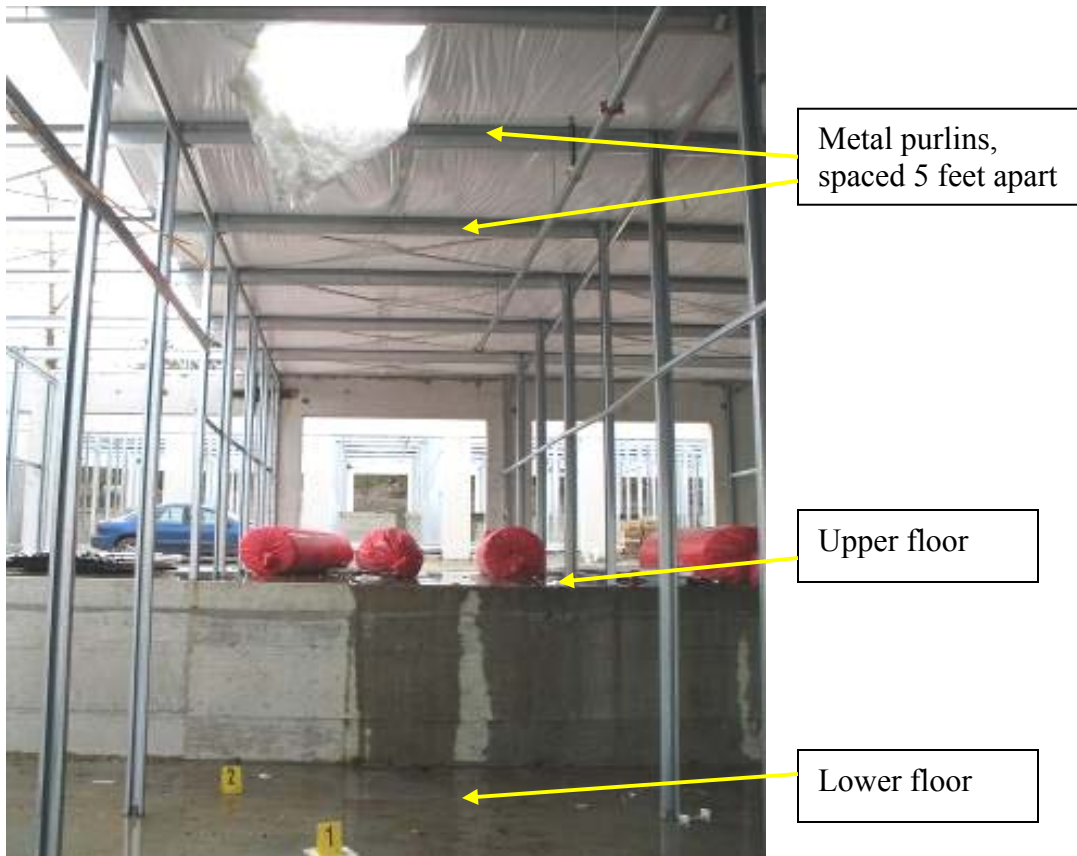
The workers left the roof and called first aid. Worker 1 was lying on the concrete floor below the hole in the insulation (see Figure 4). He died later in hospital of his injuries.

Figure 4: The hole in the insulation where Worker 1 fell to the concrete below. The red rolls of insulation are on the upper floor. The worker fell 17 feet to the lower floor level.

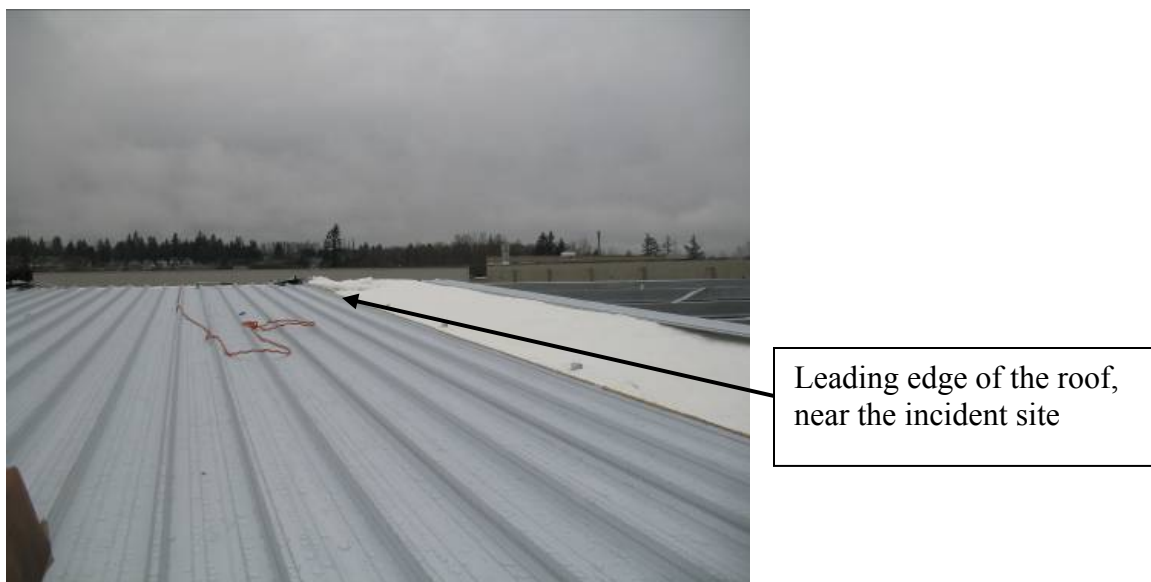
Figure 5: Roof of Building C, looking north.

The grade of the roof has a slight gradual pitch of 1:8. The height of the roof above grade varies from 11 to 17 feet. A standing seam panel system was being used for the metal roofing. Panels were placed on top of insulation, which the workers had previously laid out (see Figure 5). The 3-inch-thick blanket insulation was placed across metal purlins spaced 5 feet apart. The roof panels were 16 inches wide and arrived at the job site precut to roof length specifications. Workers were handling 41-foot-long panels on the roof of Building C. Where one panel is joined to another, there is a protruding rib.

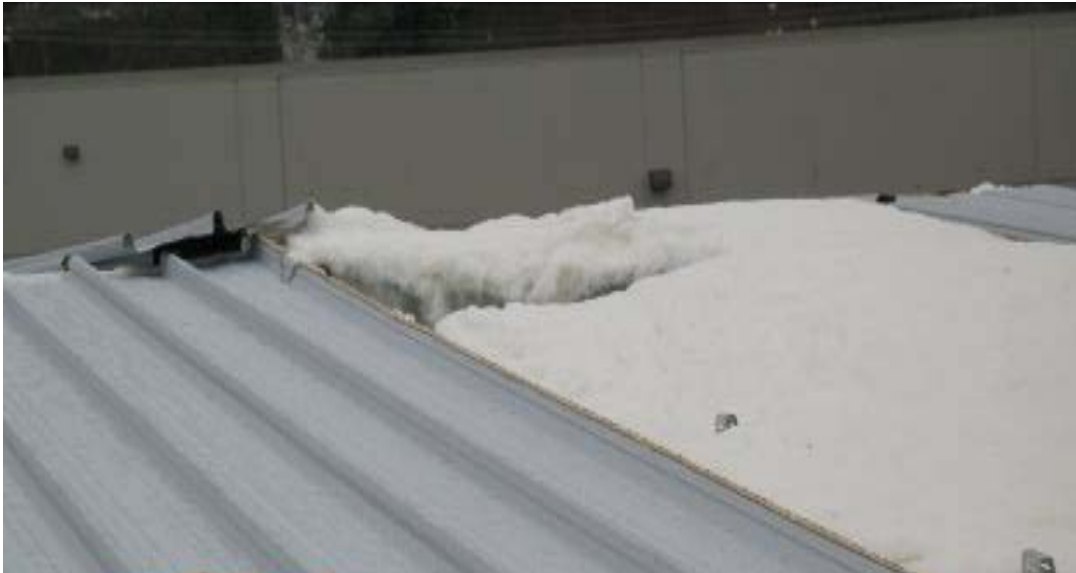
No one saw Worker 1 fall, and there is no conclusive evidence of what exactly triggered the fall. It is possible that while lowering and positioning the roof panel, Worker 1 tripped on the protruding roof panel ribs of previously fastened panels and lost his balance (see Figure 6). Unable to recover, he could then have fallen sideways onto the insulation, breaking through and landing on the concrete floor below.

Figure 6: Close up view of the hole in the insulation where Worker 1 fell. The protruding ribs on the panel are visible.

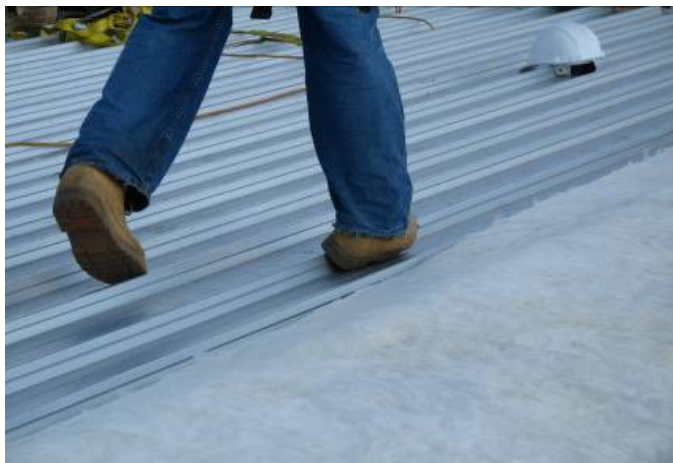
The danger of falling off the edge of the roof was not the only hazard. The panels have 1 $\frac{5}{8}$ -inch protruding ribs spaced 7.5 inches apart, which can be a tripping hazard (see Figure 7). There was no support underneath the insulation other than the purlins (metal beams) spaced 5 feet apart. To place each

new roof panel, the workers were at the edge of the roof panel beside the insulation. If a worker stepped on the insulation, it would not support his weight.

Figure 7: The protruding ribs form a tripping hazard.
