HAZARD ALERT

Electrician dies after fall from fourth-floor balcony

FATALITY
02-05

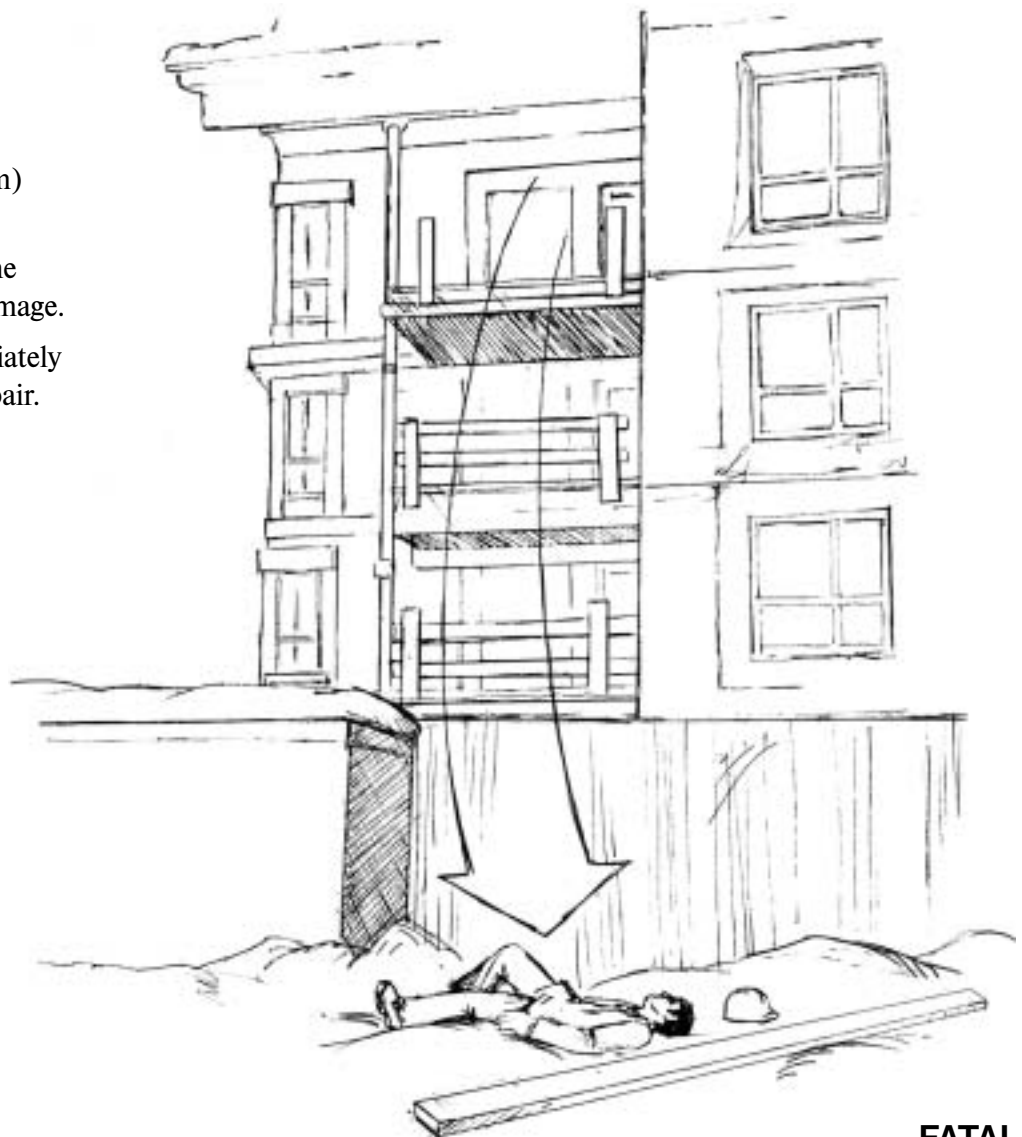
A worker fell 11 metres (35 feet) to his death from a fourth-floor balcony. There was a temporary wooden upper guardrail surrounding the balcony, but no middle guardrail.

Earlier in the day, the upper guardrail had been struck when a forklift loaded a pallet of wire up to the fourth-floor balcony. After this incident, the guardrail was not inspected or repaired. When the worker was later loading rolls of wire from the balcony into the building, he may have stumbled into or leaned against the upper guardrail. The upper guardrail was found on the ground close to the worker.

- If guardrails are incomplete, an alternative form of fall protection (such as a personal harness system) should be used.
- Guardrails contacted by a machine must be inspected for possible damage.
- Defective guardrails must immediately be reported to a supervisor for repair.
- Defective guardrails must be repaired immediately.
- Workers completing repairs to guardrails must use an alternative form of fall protection.
- A spotter should be used when loads being placed are not visible to the machine operator.
- Railings removed for load access must be replaced when possible.
