HAZARD ALERT

Young worker injured in elevator shaft

INJURY
03-05

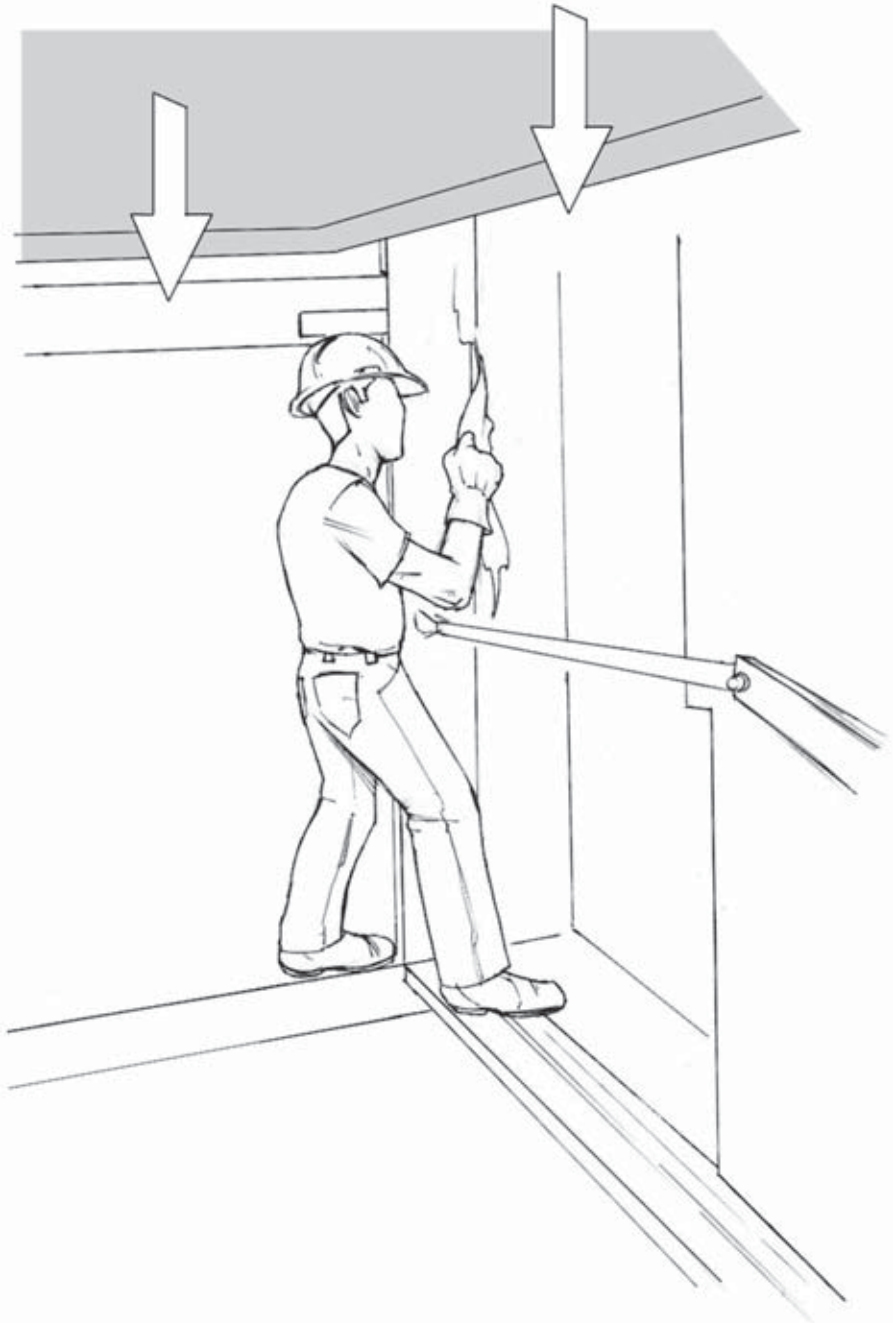
A first-year elevator apprentice was working inside an elevator shaft of a building under construction. This young worker was not aware that an elevator in this shaft was still being tested for operation by an elevator mechanic working in the elevator machinery room.

The young worker was squeezed into a 6-inch space when the elevator car moved from one floor to another. He sustained bruising to the back and front of his torso.

An accident investigation revealed that the workers did not communicate with each other and did not follow lockout procedures. The young worker had not received adequate instruction and training. The activities of the workers had not been adequately supervised.

- The employer must ensure that all workers are adequately trained, instructed, and supervised in the safe performance of their duties.
- Lockout procedures must be followed when working inside an elevator shaft.
