Written procedures and actual practice

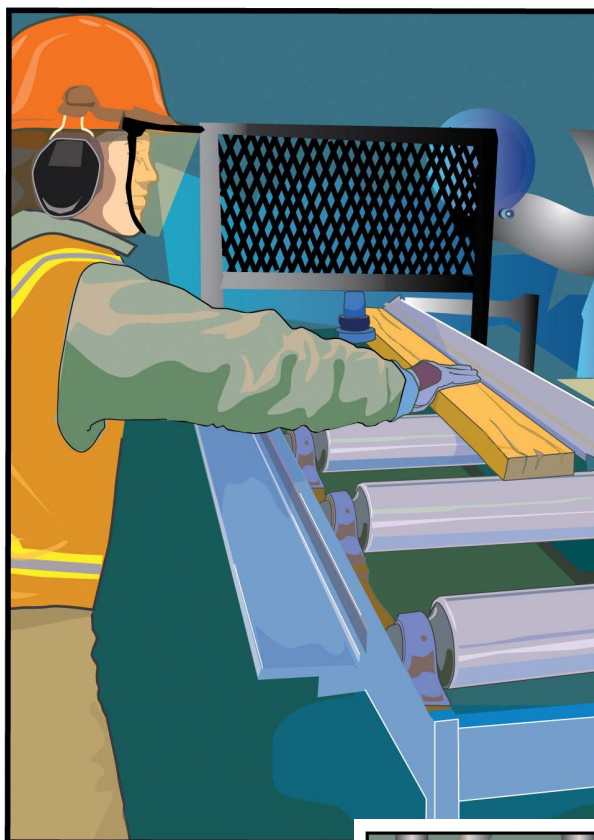
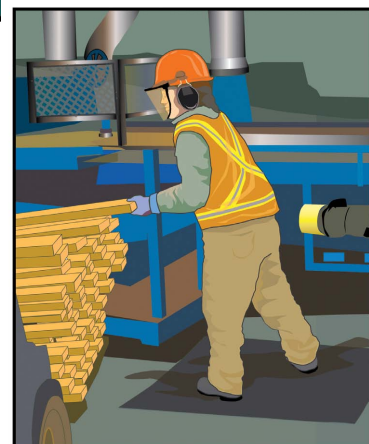
In this incident, the operator was standing at the back of the in-feed table, feeding rough lumber into the machine. While doing this, another piece of lumber "kicked-back" and was ejected out of the saw, striking a piece of lumber on the in-feed table. This caused the piece of lumber on the in-feed table to come back sharply and strike a fatal blow to the chest of the operator, who was standing in its path. There were no physical barriers in place to stop the operator from standing behind the in-feed table. Also, there were no warnings or any other signs posted about a potential kick-back hazard.

- **Machine and lumber:** On the day of the incident, the operator was processing rough lumber containing many defects. The lumber also varied in thickness to the point where the machine's in-feed rollers had to be adjusted an estimated 10 times. As well, the rubber rollers that the multi-rip saw originally came with had been replaced with steel rollers. Rubber rollers can accommodate larger variations in lumber thickness, making it easier to feed rough lumber into the machine. Processing rough lumber with a machine retrofitted with steel rollers increased the task's demands significantly.

While installing a physical barrier will restrict access to the end of the in-feed table, still, the reasons behind the worker's actions must be dealt with to improve worker safety. An effective solution would focus around the factors that drove the worker's behaviour.
