Young worker falls from third-storey balcony

Purpose of this report

Core activity: Vinyl siding installation

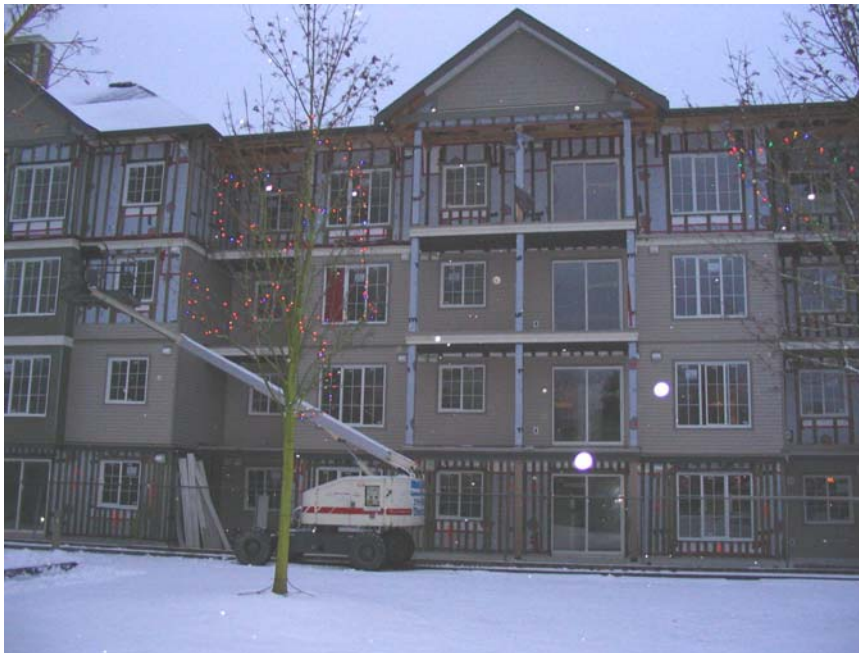
Worker 1, a young worker, fell 18 feet 6 inches from an unguarded third-storey balcony to the ground below. The worker was in the process of installing siding above the sliding door of a newly constructed four-storey apartment complex when he fell. The worker died of a severe closed head injury.

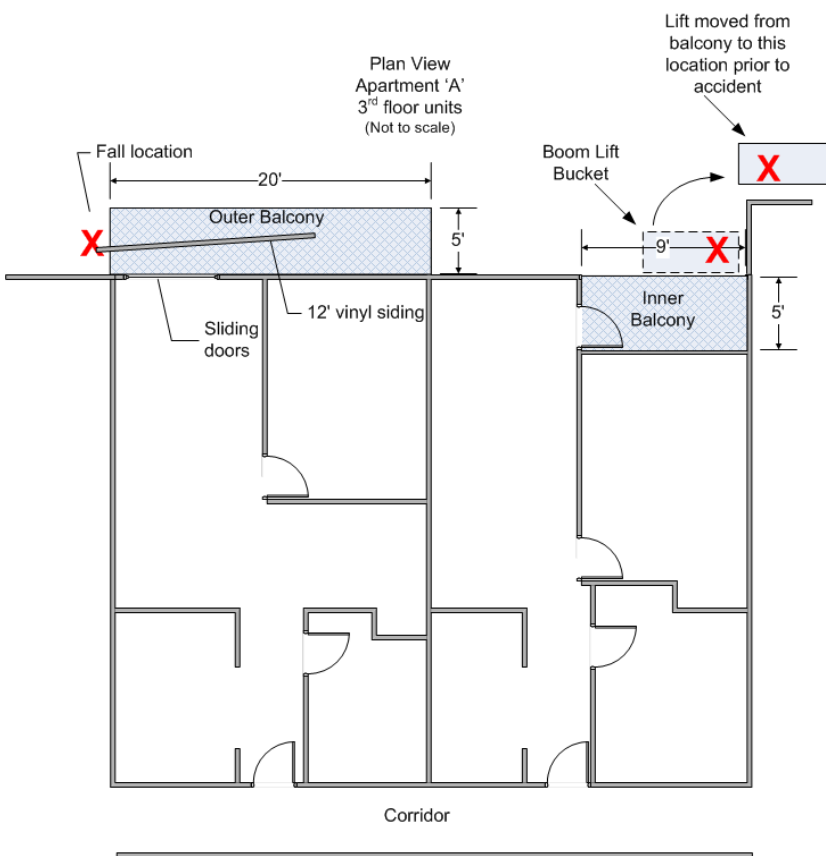
Diagram 1: This floor plan shows the inner balcony of one suite and the outer balcony another suite.

The employer assigned Worker 1 to this task. Worker 2 directed Worker 1 to go to the third floor so that the installation of the siding around the walls of the inner balcony would be finished. The inner balcony was 9 feet long and 5 feet wide and was accessible by a door from inside the unit. The deck was enclosed by three walls and had one unguarded 9-foot side. Worker 2 had positioned the bucket of the

The outer balconies are 20 feet long by 5 feet wide without guardrails on the exposed perimeter. A piece of siding is 12 feet by 8 inches. The area above the sliding doors was 18 feet by 3 inches, so two pieces of siding would be needed and would first need to be measured and cut to fit.

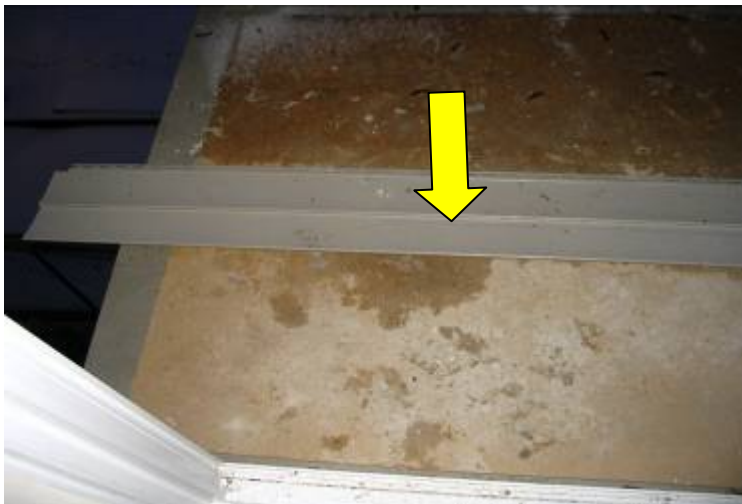
Worker 1 started work measuring the siding for the outer balcony of a third-floor suite. A 12-foot piece of siding was later found with a pencil mark scribed along its length 3 inches from the edge. The mark stopped within 30 inches of the end, and approximately 10 inches of siding was sticking past the end of the balcony (see Photo 1).

Photo 1: This photo shows the siding hanging over the unguarded end of the balcony. The arrow indicates the pencil line along the length three inches from the edge.

A 12 foot by 8 inch piece of siding was found lying on the deck (see photo 1 on page 4). A typical method of measuring a long piece of material to be cut to width is to extend your tape measure out to the desired width (in this case 3 inches) and place your pencil at the end of the tape. This requires two hands to do, and the siding would have to be placed flat on the deck. The worker would bend over to scribe the piece, walking backwards in doing so. Due to the cold wind, Worker 1 was wearing a hooded jacket which covered a portion of his lower face, cutting off his peripheral vision. The siding had been scribed with a pencil 3 inches from the edge, starting at one end and stopping 30 inches from the other end. In all likelihood he stepped backward off of the deck while marking the piece of siding.

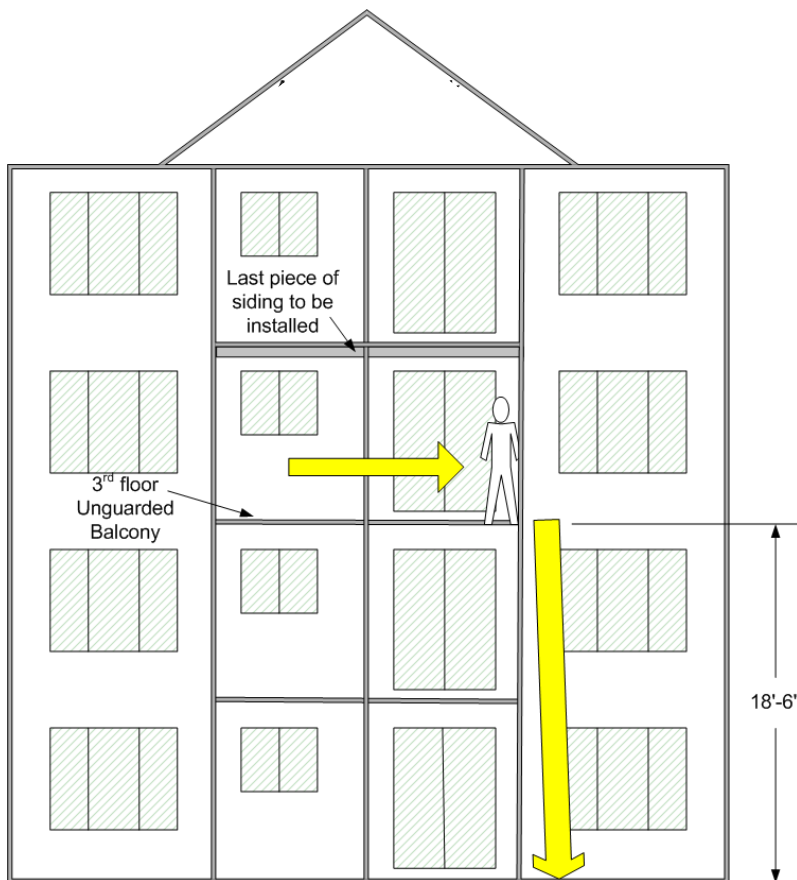
Worker 2 observed Worker 1 twice on the outer third-floor balcony (see Diagram 2). The second time, Worker 2 noticed that Worker 1's back was facing the unguarded edge of the third-floor balcony. Less than one minute after noticing Worker 1 the second time, Worker 2 heard a crash and saw Worker 1 on the ground below. He was wearing a hooded jacket with the hood over his head.

Diagram 2: This shows the elevation view of the apartment block. Arrows indicate Worker 1's fall location. He did not project outward in the fall, but landed near the edge of the end of the balcony, as if he stepped backward off the edge.

- 1) The worker fell 18 feet 6 inches from a balcony and died of a severe head injury.
- 2) There were no guardrails and the worker did not wear personal fall protection.
- 3) There were no written training records for this young worker.
- 4) There was no fall protection plan established for the work being done.
- 5) There was no evidence that supervisors were monitoring or recording that safe work practices were being used and that job procedures were being followed.
- 6) Management was not monitoring records and reviewing results with the supervisor on a regular basis.
- 7) The prime contractor was not coordinating all the health and safety activities of employers on this worksite.

- Provide workers with adequate instruction, training, and supervision necessary to ensure the health and safety of those workers in carrying out their work duties.
- Where workers are working at heights 3 metres (10 feet) or more, or where a fall from a height involves an unusual risk of injury, ensure that workers are protected from falling in accordance with the requirements set out in Part 11 of the Occupational Health and Safety Regulation.
- Develop an adequate fall protection plan that is site-specific when workers are working over 7.5 metres (25 feet) in height.
