ENGINEERING SECTION REPORT

Bus Drivers & Human Vibration

Report By: Stuart Eaton

Date: September, 2003

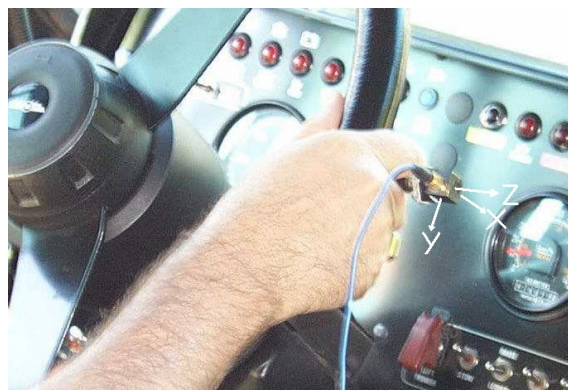
A triaxial accelerometer (mass = 10.6 gm) was mounted on a small hand-adapter (see sketch). In use, the adapter's base was held by the driver against the driving wheel, while being gripped between two digits of the hand being tested. In this way, vibration of the handle was sampled along the three mutually orthogonal basicentric axes of the hand, the x-, y- and z-axes (see photograph). The accelerometer, was calibrated by the accelerometer calibrator and agreed to within 3% of the manufacturer's accelerometer sensitivity calibration.

The driver was requested to prevent the wheel from sliding through his hands while steering; he was requested to maintain a firm grip throughout the measurement sample. This measure was to prevent extraneous vibration which may have been generated in the sliding action of the hand over the finger grips moulded in the steering wheel when turning corners.

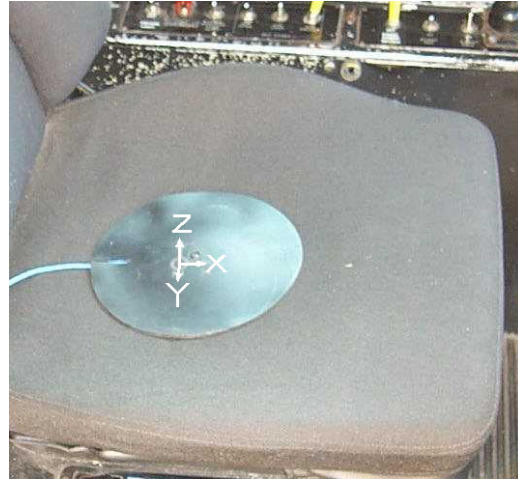
ISO 2631-1 requires measurement of frequency-weighted acceleration at the point of entry into the body. Acceleration measurements must be performed along three mutually perpendicular directions in space (see sketch). The sensitivity of the body to vibration at different frequencies is accounted for by frequency weightings inserted into the measurement chain. Frequency weighting, W_d , is identical for the x- and y-directions; the frequency weighting, W_k , for the z-direction differs.

A triaxial accelerometer, embedded in a nitrile rubber seat pad, was placed in the centre of the driver's seat with axes aligned as in the diagram (see photograph) and the driver was requested to sit on the cushion.
