HAZARD ALERT

MSA Ultra Elite[®] SCBA facepiece Install corrective valve stem guard

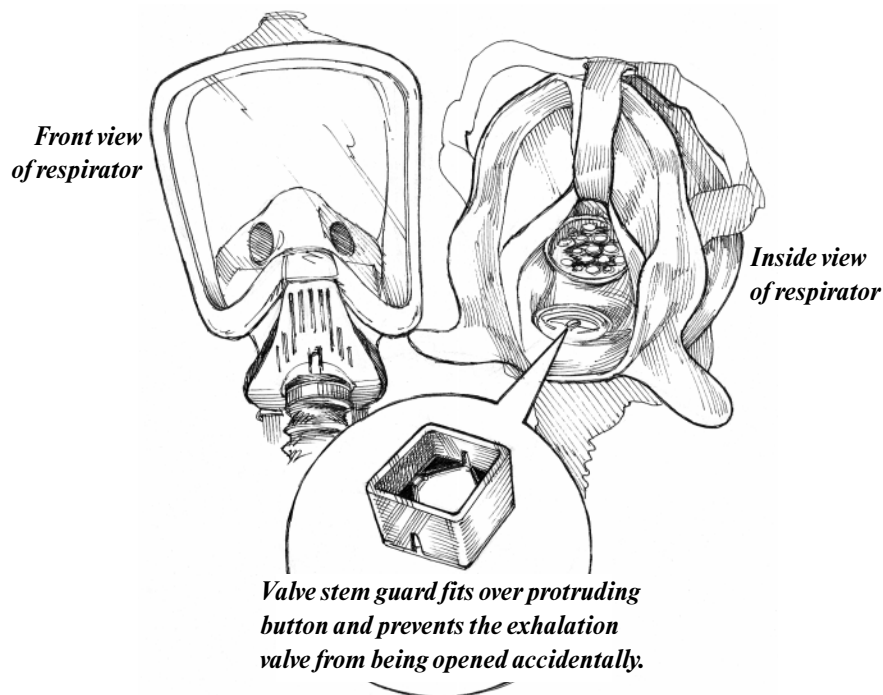
A safety design defect has been found with the exhalation valve on the MSA (Mine Safety Appliances Company) Ultra Elite[®] SCBA facepiece. The exhalation valve can be opened for cleaning. The button that opens it protrudes above the surrounding facepiece. As a result, the button can accidentally contact the user's chin, push the exhalation valve open, and permit outside air to enter, possibly causing injury or death.

The protruding button may contact the user's chin when the user looks up, the user leans forward and looks directly down, or the user opens his or her mouth wide to breathe.

MSA has developed a guard that prevents the button from being accidentally depressed. The guard and installation instructions have been sent to all customers who purchased this facepiece. Employers should ensure that the guard is installed according to the manufacturer's instructions. If you have not received your guard, contact MSA at 416 667-9400 or toll-free at 1 800 267-0672.
