HAZARD ALERT

Excavator operator fatally crushed as concrete building collapses

FATALITY
03-02

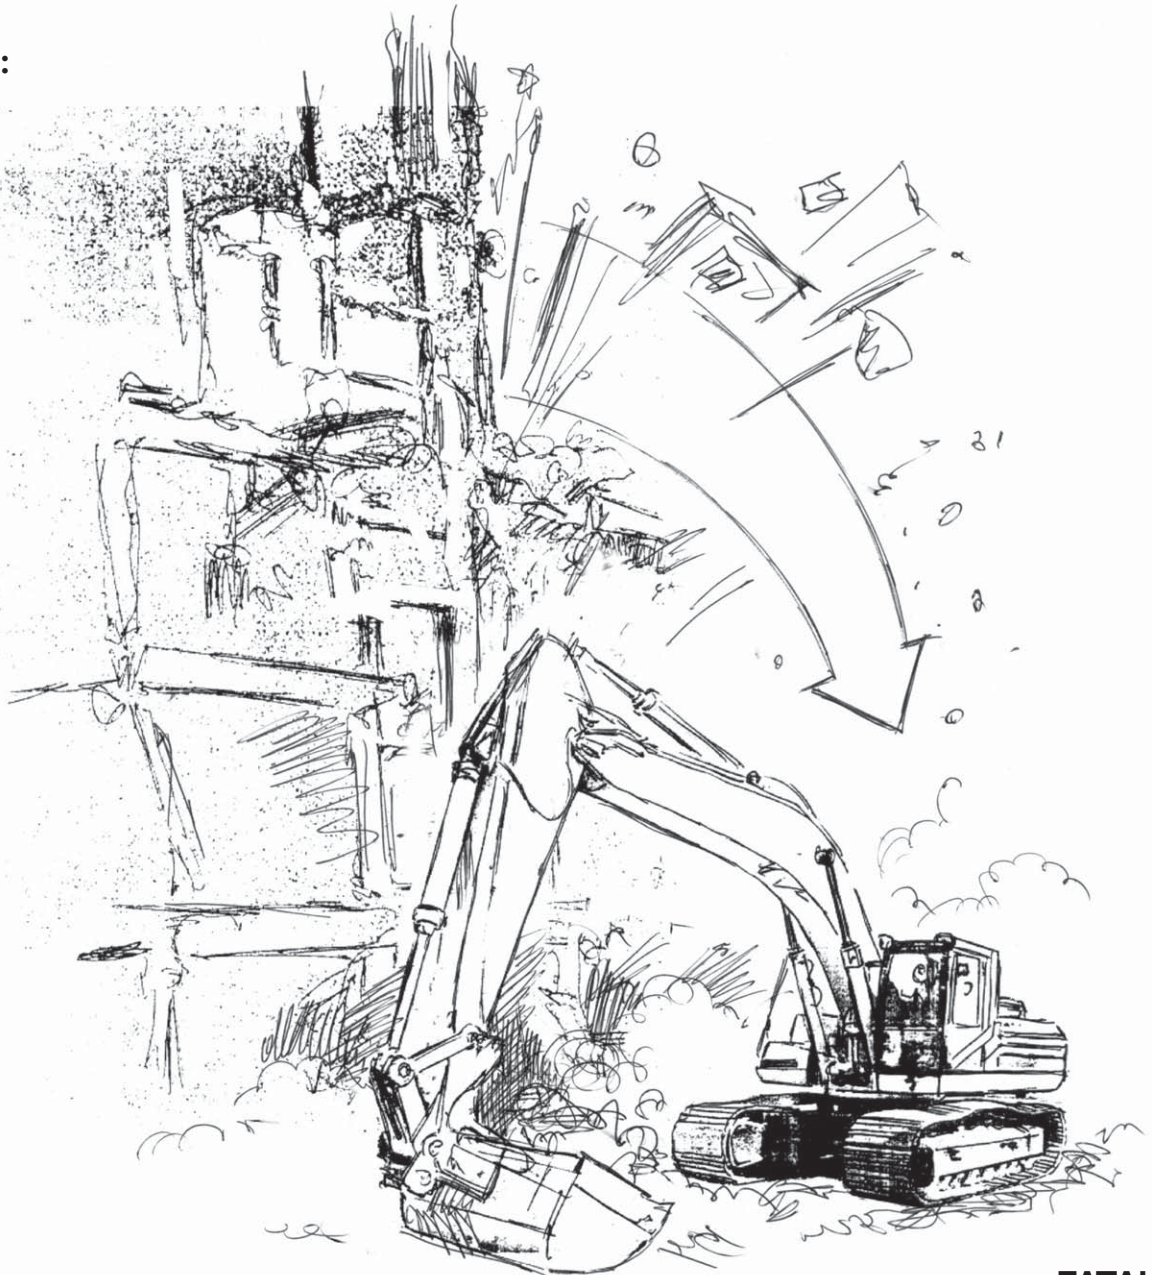
A worker was using an excavator bucket to demolish a building. The worker had been instructed to follow a demolition plan, but he decided to change the plan. While he was excavating a column, the structure collapsed onto his excavator, crushing him inside the operator cab.

- Written demolition procedures must be available on site.
- Workers must not change a demolition plan unless it is discussed with and agreed upon by the demolition supervisor and/or structural engineer and other co-workers.
