HAZARD ALERT

Industry: Log Home Construction

Worker falls while dismantling log home

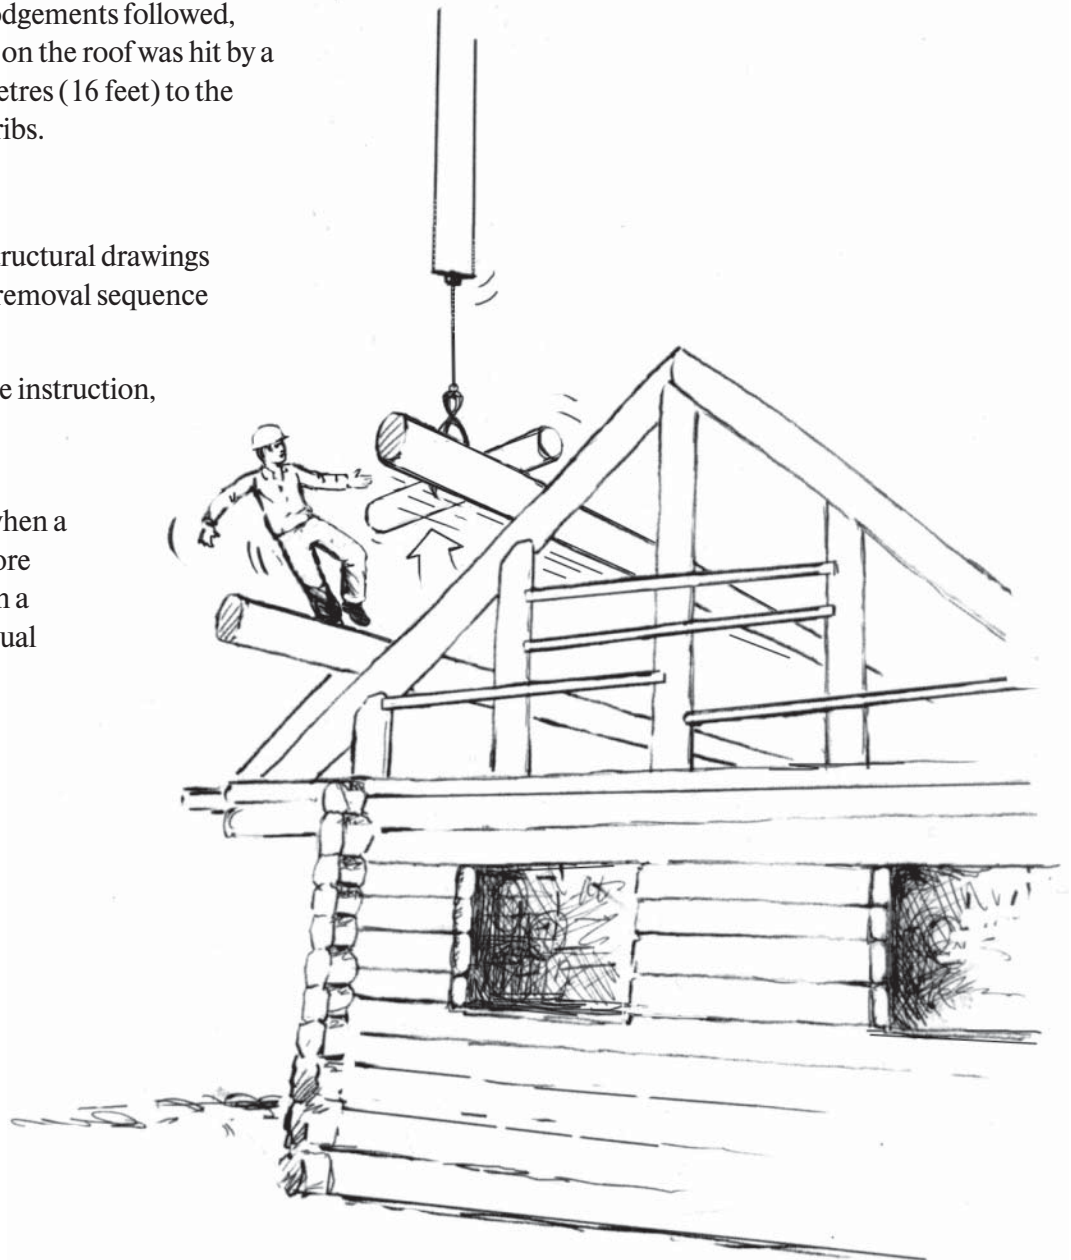
Beginning at the peak of the roof, the ridgepole was removed, followed by the filler-piece braces supporting it. The tongs were then set on the filler-piece brace below the first purlin to be removed. When the crane operator lifted out this load-bearing brace, the purlin above it – which now had no support – dislodged.

A cascade of roof member dislodgements followed, collapsing the roof. The worker on the roof was hit by a falling purlin and fell about 5 metres (16 feet) to the ground, breaking several of his ribs.

- Have written procedures or structural drawings detailing the installation and removal sequence of load-bearing members.
- Ensure workers have adequate instruction, training, and supervision in dismantling procedures.
- Use a fall protection system when a fall of 3 metres (10 feet) or more may occur or where a fall from a lesser height involves an unusual risk of injury.
