## Worker survives excavator rollover

The purpose of this online incident investigation report is to identify the causes and contributing factors of this incident to help prevent similar incidents and to support preventive actions by industry and WorkSafeBC. This online version is not the official WorkSafeBC report. It has been edited to remove personal identifying information, some photographs, and details not essential to understanding the cause of the incident.

NI number: 2005138190147

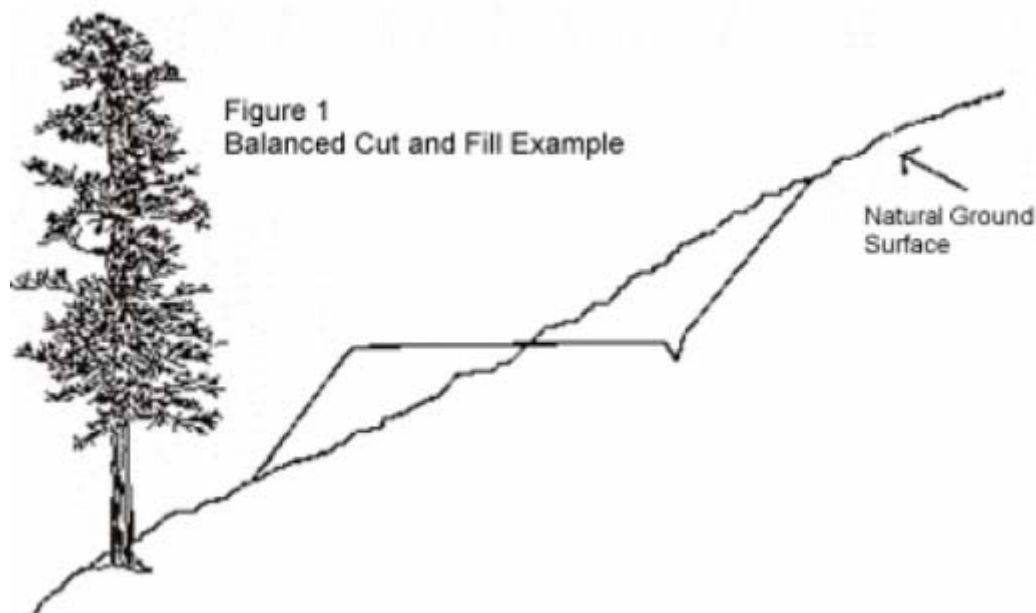
Bench construction is also known as balanced cut and fill construction. What this means is that a portion of the road will be cut into the hillside and the rest of the road will be built with filling or side casting (see Figure 1). The incident site called for  $\frac{3}{4}$  bench endhaul, which means that  $\frac{3}{4}$  of the road would be cut into the hill and  $\frac{1}{4}$  would be built with filling or side casting, and the extra materials would be hauled away with trucks.

Figure 1: Bench construction, or balanced cut and fill. Source: [Forest Roads Manual](#), Section 4. Oregon Department of Forestry. Used with permission.
