Worker pinned between forklift load and pile of veneer

Number: 2005116110061

Core activity: Veneer manufacture

Date of incident: March 2005

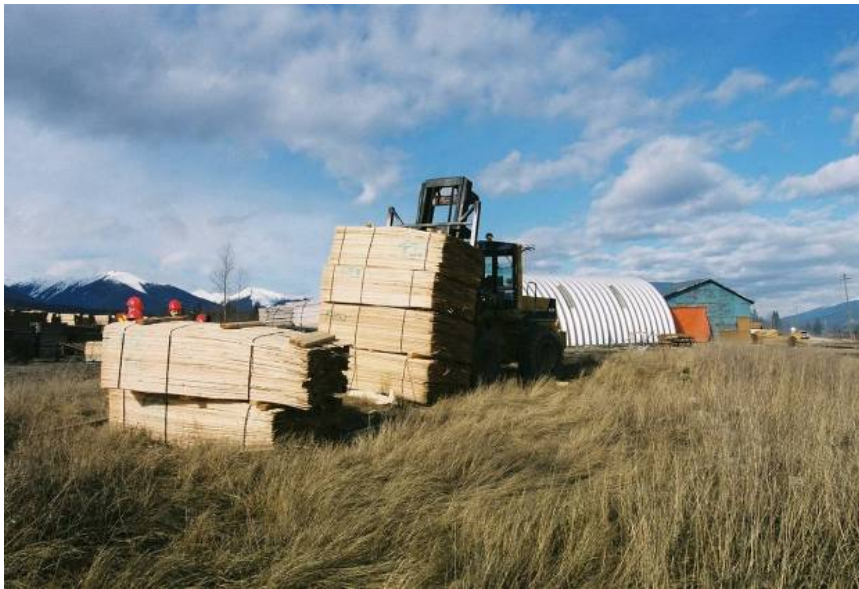
At a veneer and lumber manufacturing plant a spareman was working in an area alone during the night shift. The spareman parked and exited a forklift loaded with four stacks of veneer. He entered the area in front of the machine. The mobile equipment rolled forward and pinned the spareman between the load carried on the forklift and two stacks of veneer he had previously positioned on the ground. A supervisor found the spareman, deceased, about one and a half hours after he had last seen him.
