Worker survives excavator rollover

Number: 2005138190147

Core activity: Logging road construction

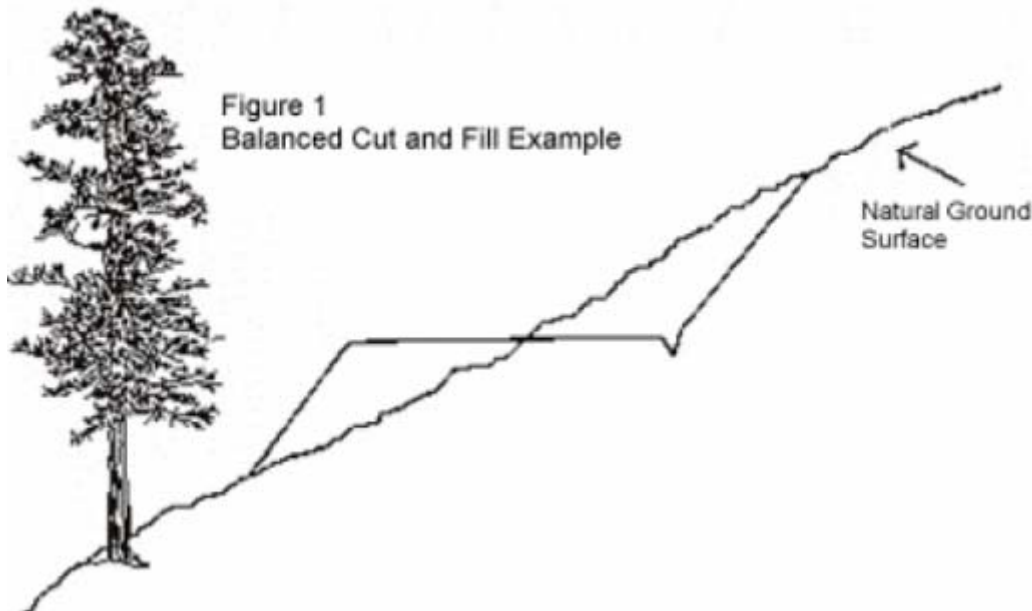
Bench construction is also known as balanced cut and fill construction. What this means is that a portion of the road will be cut into the hillside and the rest of the road will be built with filling or side casting (see Figure 1). The incident site called for $\frac{3}{4}$ bench endhaul, which means that $\frac{3}{4}$ of the road would be cut into the hill and $\frac{1}{4}$ would be built with filling or side casting, and the extra materials would be hauled away with trucks.

Figure 1: Bench construction, or balanced cut and fill. Source: [Forest Roads Manual](#), Section 4. Oregon Department of Forestry. Used with permission.
