Framer falls through stair openings

Purpose of this report

Number: 2006155070109

Outcome: Fatal

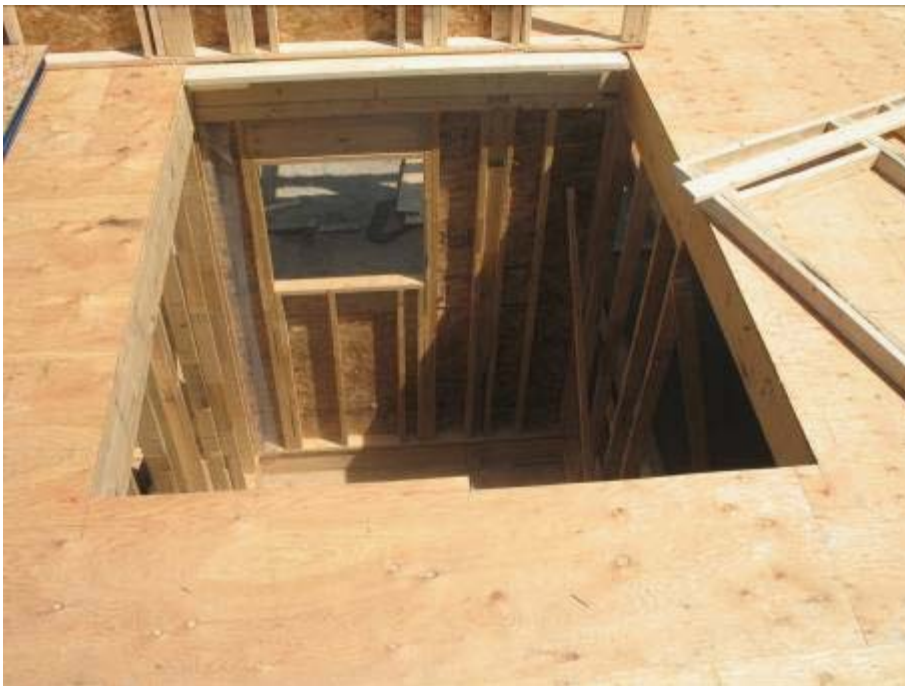
A framer was framing walls on the third level of a three-storey single-family dwelling. He was working beside an uncovered stair opening with no guardrail. The stair openings for the second and third levels were vertically aligned. The stairways had not yet been constructed, so there was a drop of 18.5 feet from the third level to the first-level basement concrete floor. The framer fell through the successive openings to the concrete floor below. He was taken to hospital but later died of his injuries.
