Worker falls through roof insulation to concrete floor

Purpose of this report

Number: 2007157520114

Core activity: Applying roofing materials to building under construction

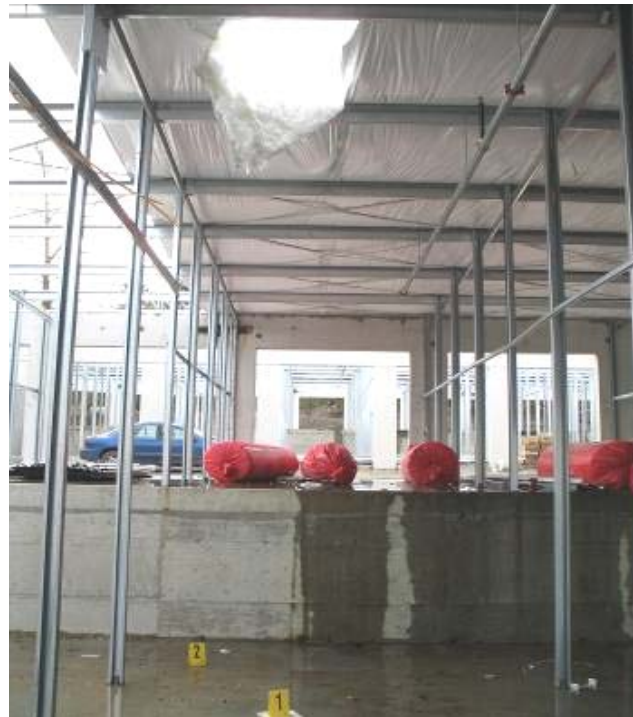
Four workers were working on the relatively flat roof of a structural steel building. They were laying down metal roof panels over a layer of blanket insulation that had already been placed across the metal roof beams. One of the workers fell through the insulation to the concrete floor 17 feet (5.2 metres) below. The worker died in hospital from his injuries.
