# FATAL

POSTER # 97-10

## Secure loads and do not exceed load capacity

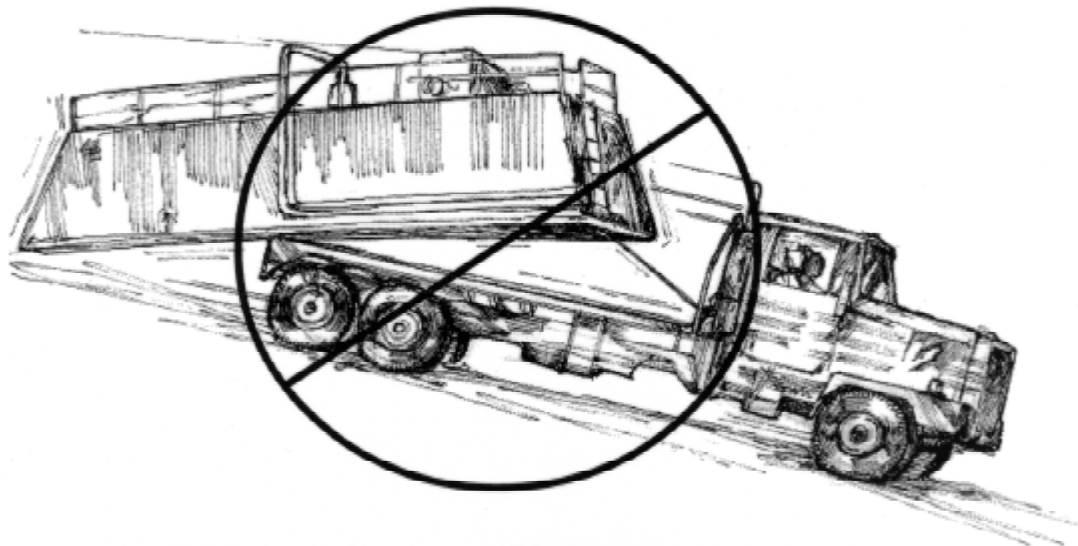
A swamper, riding in the passenger seat of a tandem-bed truck, was crushed and killed when a heavy mud tank, carried on the truck bed, rolled forward crushing the cab. The large 35,000 lb. tank was secured only by a winch cable. The large tank, balanced on a rear roller, extended well beyond the end of the truck deck. As the truck descended a steep hill the tank moved forward on the roller, crashing into and crushing the cab.

- Employers, ensure that all workers receive adequate instruction in the safe performance of their duties.
- Ensure that all loads are properly secured before moving a vehicle.
- Use the proper equipment, with sufficient carrying capacity, before attempting to move any equipment or load.
