HAZARD ALERT

Lock out before servicing

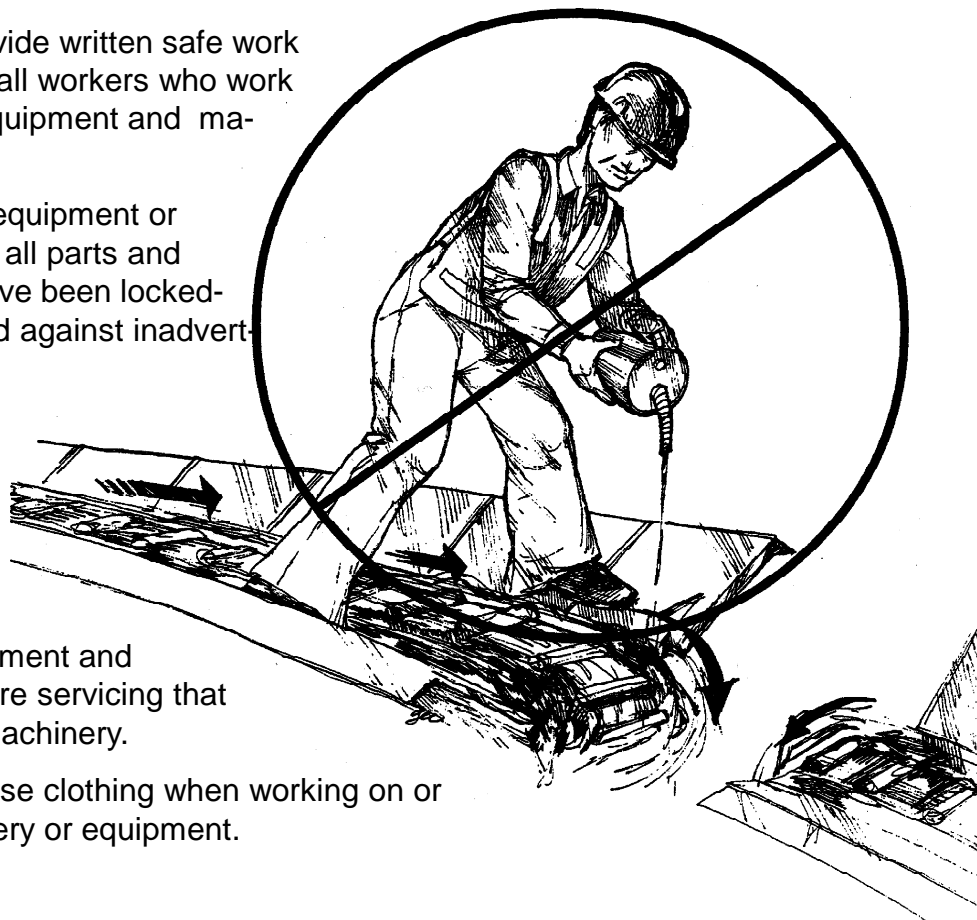
As he was oiling a moving conveyor, a worker's pant leg became entangled in the part of the conveyor, causing his right foot to be dragged in and crushed between the head sprocket and the side of the conveyor. His right leg had to be amputated below his knee. The worker usually oiled the conveyor from a relatively safe position from underneath the conveyor. For some reason, on this day, he decided to oil the conveyor from an unstable position above the conveyor without locking out. His pant legs also hung down below his boots.

- Employers, provide written safe work procedures for all workers who work on or around equipment and machinery.
- Do not service equipment or machinery until all parts and attachments have been locked-out and secured against inadvertent movement.
- Ensure that you have safe and proper access and egress to equipment and machinery before servicing that equipment or machinery.
- Do not wear loose clothing when working on or around machinery or equipment.
