FATAL

Clear out exposed, unstable trees

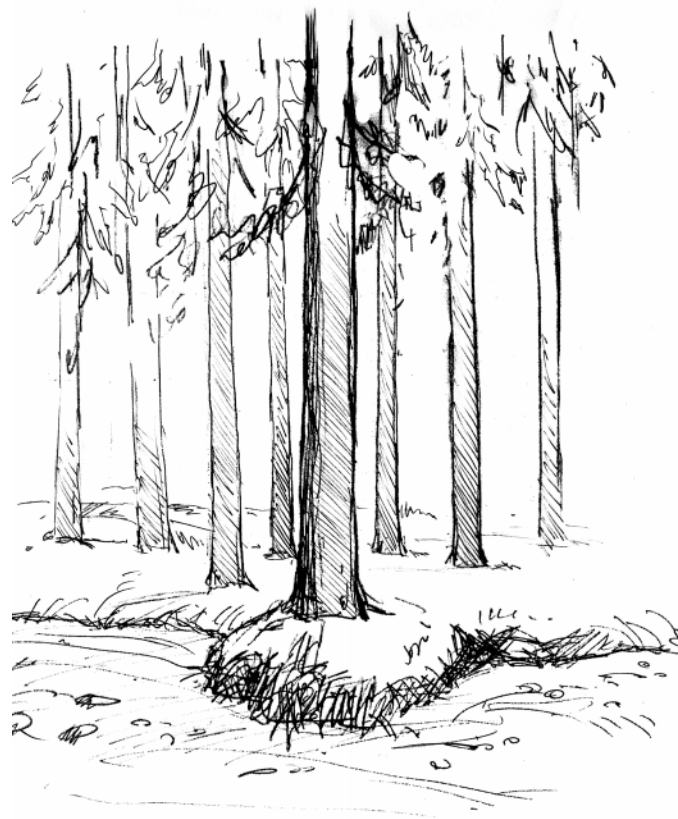
A worker was killed when high winds uprooted a tree 37 metres (120 ft.) high. When the tree fell, the worker was working across a roadway, about 27 metres (90 ft.) from the base of the falling tree. The tree uprooted, falling across the roadway and striking the worker on the head. Selective logging for home sites had left some of the second-growth trees exposed to the prevailing winds. A number of these trees had damaged root systems, and the soil around them was of a sandy, gravelly nature.

- Ensure that trees left standing after selective clearing are inspected by a qualified person to ensure that they are firmly rooted and stable.
- Clear out exposed, unstable trees.
- Move workers out of work areas where high winds could expose them to the danger of falling trees.
